**DEPARTMENT OF TRANSPORTATION**

Contract #: 04-0120F4Cty: SF/ALA Rte: 80 PM: 13.2/13.9File #: 69.28**WELDING INSPECTION REPORT****Resident Engineer:** Pursell, Gary**Address:** 333 Burma Road**City:** Oakland, CA 94607**Report No:** WIR-015440**Date Inspected:** 02-Jul-2010**Project Name:** SAS Superstructure**OSM Arrival Time:** 700**Prime Contractor:** American Bridge/Fluor Enterprises, a JV**OSM Departure Time:** 1900**Contractor:** Zhenhua Port Machinery Company, Ltd (ZPMC), Changxing Island **Location:** Shanghai, China

**DECK PANEL 13CE-DP3104-001**

## WELDING INSPECTION REPORT

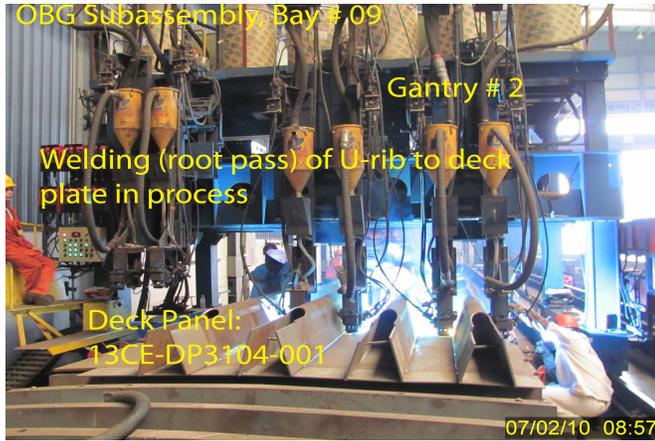
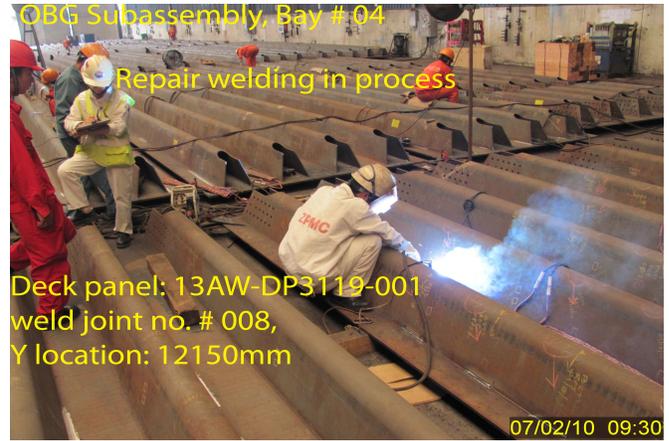
Gas Metal Arc and Submerged Arc Welding (GMAW/SAW) of DP3104-001 in process on gantry # 2. ZPMC Quality Control (QC) is identified as Mr. Zhu Zhong Jie. Weld Procedure Specification (WPS) is identified as WPS-B-T-2342-U1(urib)-5. Welding appears to conform to the requirements of the WPS used. The weld number and welder for respected weld are as follows.

During random in process inspection this QA inspector observed that ZPMC personnel were performing repair welding on the Partial Joint Penetration (PJP) weld joints of deck panel 13AW-DP3119-001. Welders are identified as 062750 & 068916. ZPMC CWI is identified as Mr. Yang Bai Qiang. The welding variables recorded by QC appeared to comply with WPS-345-FCAW-2G(2F)-FCM-Repair. The repair area details are as follows.
