Contract #: 04-0120F4Cty: SF/ALA Rte: 80 PM: 13.2/13.9File #: 69.28**WELDING INSPECTION REPORT****Resident Engineer:** Pursell, Gary**Address:** 333 Burma Road**City:** Oakland, CA 94607**Report No:** WIR-015479**Date Inspected:** 07-Jul-2010**Project Name:** SAS Superstructure**OSM Arrival Time:** 645**Prime Contractor:** American Bridge/Fluor Enterprises, a JV**OSM Departure Time:** 1845**Contractor:** Zhenhua Port Machinery Company, Ltd (ZPMC), Changxing Island **Location:** Shanghai, China**CWI Name:** Li Bai Qang.**CWI Present:** Yes No**Inspected CWI report:** Yes No N/A**Rod Oven in Use:** Yes No N/A**Electrode to specification:** Yes No N/A**Weld Procedures Followed:** Yes No N/A**Qualified Welders:** Yes No N/A**Verified Joint Fit-up:** Yes No N/A**Approved Drawings:** Yes No N/A**Approved WPS:** Yes No N/A**Delayed / Cancelled:** Yes No N/A**Bridge No:** 34-0006**Component:** Orthotropic Box Girder (OBG)**Summary of Items Observed:**

Subassembly, Bay 04, Deck Panel 13CE-DP3107-001.

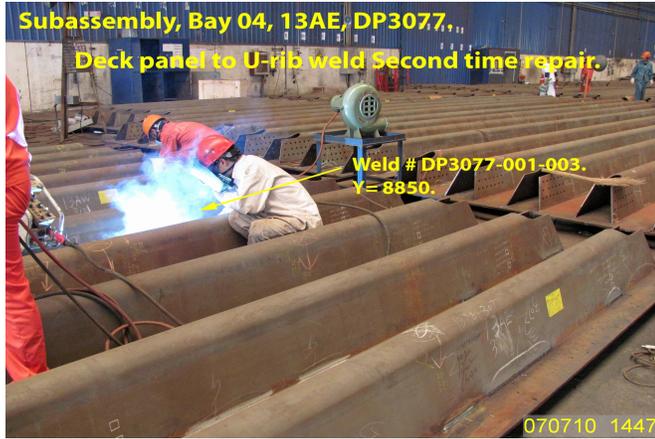
FCAW Second time Repair welding of partial penetration weld joints DP3077(PL3173)-001-003, 010; located on subassembly, Bay 04, 13AE. Welder is identified as 068596; ZPMC Quality Control Inspector (QC) is identified as Li Bai Qang. The welding variables recorded by Quality Control Inspector (QC) appeared to comply with the Applicable WPS: WPS-345-FCAW-2G(2F)-FCM-REPAIR.

Y-location of repairs were

003 - 8850.

010 – 2250.

The attached photographs provide additional detail.
