**DEPARTMENT OF TRANSPORTATION**

Contract #: 04-0120F4Cty: SF/ALA Rte: 80 PM: 13.2/13.9File #: 1.28**WELDING INSPECTION REPORT****Resident Engineer:** Pursell, Gary**Address:** 333 Burma Road**City:** Oakland, CA 94607**Report No:** WIR-015563**Date Inspected:** 09-Jul-2010**Project Name:** SAS Superstructure**OSM Arrival Time:** 1100**Prime Contractor:** American Bridge/Fluor Enterprises, a JV**OSM Departure Time:** 1930**Contractor:** American Bridge/Fluor Enterprises, a JV**Location:** Job Site**CWI Name:** See Below**CWI Present:** Yes No**Inspected CWI report:** Yes No N/A**Rod Oven in Use:** Yes No N/A**Electrode to specification:** Yes No N/A**Weld Procedures Followed:** Yes No N/A**Qualified Welders:** Yes No N/A**Verified Joint Fit-up:** Yes No N/A**Approved Drawings:** Yes No N/A**Approved WPS:** Yes No N/A**Delayed / Cancelled:** Yes No N/A**Bridge No:** 34-0006**Component:** Orthotropic Box Girders**Summary of Items Observed:**

A). Field Splice W5/W6

## WELDING INSPECTION REPORT

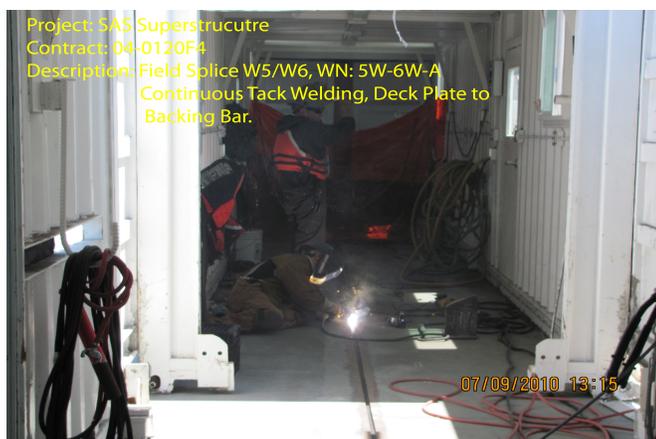
The QAI observed the welder Hua Qiang Hwang ID-2930 perform the continuous tack welding of the deck plate to the backing bar on the weld joint identified as WN: 5W-6W-A1. The welding was performed utilizing the Flux Cored Arc Welding (FCAW-G) process as per the Welding Procedure Specification (WPS) identified as ABF-WPS-D15-F3200-2 Rev. 0. The welding was performed in the horizontal (2F) with the welding deposited on the upper side of the horizontal surface and against the vertical surface. The WPS was also used by the QC inspector, Steve McConnell, to monitor the in process welding and verify the welding parameters. The welding parameters were verified and recorded by Mr. Daquinag as follows; 235 amps, 21.5 volts with a travel speed measured at 277 mm/minute. The minimum preheat temperature of 60 degrees Celsius and a maximum interpass temperature of 230 degrees Celsius was also verified by the QC inspector.

The QAI also observed the welder James Zhen ID-6001 perform the continuous tack welding of the deck plate to the backing bar connection of the weld joint identified as WN: 5W-6W-A5. The welding was performed utilizing the Flux Cored Arc Welding (FCAW-G) process as per the Welding Procedure Specification (WPS) identified as ABF-WPS-D15-F3200-2 Rev. 0. The WPS were also used by the QC inspector, Steve McConnell, to monitor the

The digital photograph below illustrates the work observed during this scheduled shift.
