Contract #: 04-0120F4Cty: SF/ALA Rte: 80 PM: 13.2/13.9File #: 69.28**WELDING INSPECTION REPORT****Resident Engineer:** Pursell, Gary**Address:** 333 Burma Road**City:** Oakland, CA 94607**Report No:** WIR-015574**Date Inspected:** 08-Jul-2010**Project Name:** SAS Superstructure**OSM Arrival Time:** 700**Prime Contractor:** American Bridge/Fluor Enterprises, a JV**OSM Departure Time:** 1900**Contractor:** Zhenhua Port Machinery Company, Ltd (ZPMC), Changxing Island **Location:** Shanghai, China

CWI Name:	Mr. Huang min / Mr. Xu xian ping			CWI Present:	Yes	No	
Inspected CWI report:	Yes	No	N/A	Rod Oven in Use:	Yes	No	N/A
Electrode to specification:	Yes	No	N/A	Weld Procedures Followed:	Yes	No	N/A
Qualified Welders:	Yes	No	N/A	Verified Joint Fit-up:	Yes	No	N/A
Approved Drawings:	Yes	No	N/A	Approved WPS:	Yes	No	N/A
				Delayed / Cancelled:	Yes	No	N/A
Bridge No:	34-0006			Component:	Orthotropic Box Girder (OBG)

WELDING INSPECTION REPORT

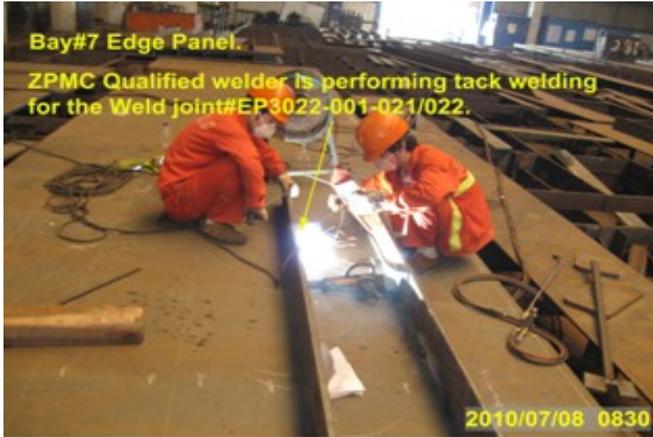
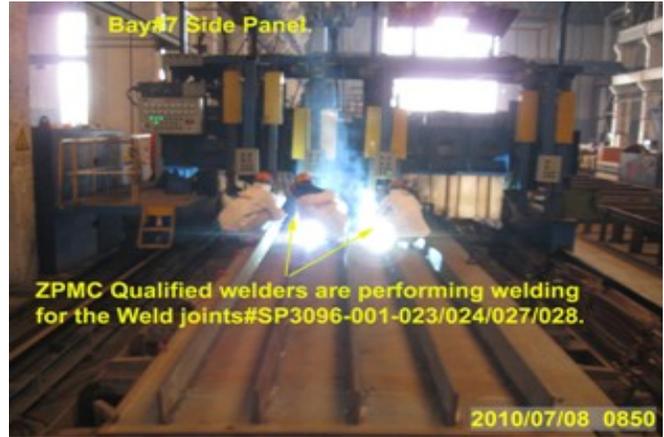
SMAW Tack welding of weld joint EP3022-001-021/022. Welder is identified as 049485. ZPMC Quality Control (QC) is identified as Mr. Cui jun jie. The welding variables appeared to comply with the Applicable WPS: WPS-B- P-2112. Refer the attached photo for reference.

Flux Cored Arc Welding (FCAW) of weld joint SP3096-001-023/024. Welder is identified as 204342. ZPMC Quality Control (QC) is identified as Mr. Wang Liang. The welding variables appeared to comply with the Applicable WPS: WPS-B- T-2132-3. Refer the attached photo for reference.

FCAW of weld joint SP3096-001-027/028. Welder is identified as 217185. ZPMC Quality Control (QC) is

identified as Mr. Wang Liang. The welding variables appeared to comply with the Applicable WPS: WPS-B-T-2132-3. Refer the attached photo for reference.
