Contract #: 04-0120F4Cty: SF/ALA Rte: 80 PM: 13.2/13.9File #: 69.28**WELDING INSPECTION REPORT****Resident Engineer:** Pursell, Gary**Address:** 333 Burma Road**City:** Oakland, CA 94607**Report No:** WIR-015685**Date Inspected:** 15-Jul-2010**Project Name:** SAS Superstructure**OSM Arrival Time:** 700**Prime Contractor:** American Bridge/Fluor Enterprises, a JV**OSM Departure Time:** 1900**Contractor:** Zhenhua Port Machinery Company, Ltd (ZPMC), Changxing Island **Location:** Shanghai, China**CWI Name:** Mr. Huang min**CWI Present:** Yes No**Inspected CWI report:** Yes No N/A**Rod Oven in Use:** Yes No N/A**Electrode to specification:** Yes No N/A**Weld Procedures Followed:** Yes No N/A**Qualified Welders:** Yes No N/A**Verified Joint Fit-up:** Yes No N/A**Approved Drawings:** Yes No N/A**Approved WPS:** Yes No N/A**Delayed / Cancelled:** Yes No N/A**Bridge No:** 34-0006**Component:** Orthotropic Box Girder (OBG)**Summary of Items Observed:**

This CALTRANS OSM Quality Assurance Inspector (QA) Surendra Prabhu was present during the times noted above for observations relative to the fabrication of the Self Anchored Suspension (SAS) Superstructure being performed by Zhenhua Port Ma

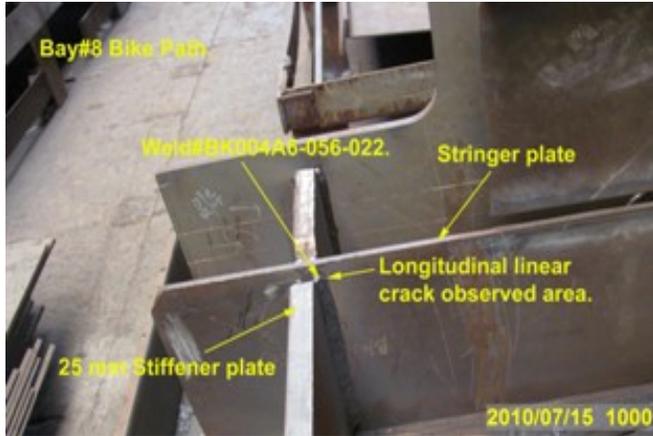
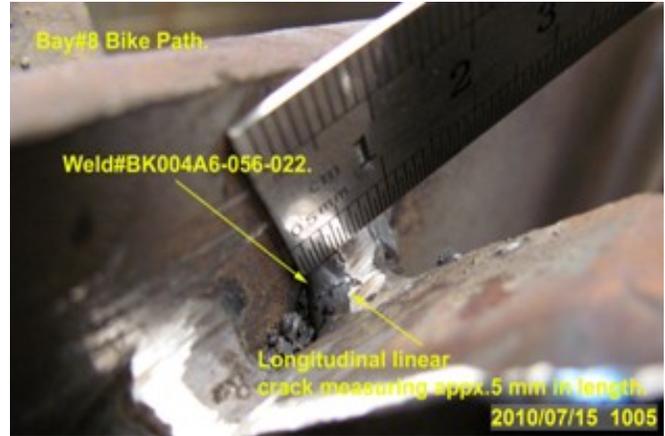
During random in process inspection of OBG member identified as Bike Path BK004A6-056, this QA observed a longitudinal linear crack measuring approximately 5 mm in length on weld joint identified as BK004A6-056-022. This QA marked the cracked area and informed ZPMC Quality Control (QC) identified as Mr. Feng Ya Jun of this issue. Mr. Feng Ya Jun informed this QA that the crack would be corrected in a manner compliant with the contract documents. Refer the attached photos for reference.
