Contract #: 04-0120F4Cty: SF/ALA Rte: 80 PM: 13.2/13.9File #: 82.28**WELDING INSPECTION REPORT****Resident Engineer:** Pursell, Gary**Address:** 333 Burma Road**City:** Oakland, CA 94607**Report No:** WIR-015841**Date Inspected:** 21-Jul-2010**Project Name:** SAS Superstructure**OSM Arrival Time:** 500**Prime Contractor:** American Bridge/Fluor Enterprises, a JV**OSM Departure Time:** 1330**Contractor:** Westmont Industries**Location:** Santa Fe Springs, CA.**CWI Name:** Rick Rodriguez**CWI Present:** Yes No**Inspected CWI report:** Yes No N/A**Rod Oven in Use:** Yes No N/A**Electrode to specification:** Yes No N/A**Weld Procedures Followed:** Yes No N/A**Qualified Welders:** Yes No N/A**Verified Joint Fit-up:** Yes No N/A**Approved Drawings:** Yes No N/A**Approved WPS:** Yes No N/A**Delayed / Cancelled:** Yes No N/A**Bridge No:** 34-0006**Component:** Travelers**Summary of Items Observed:**

Traveler Rails E2/E3-EB

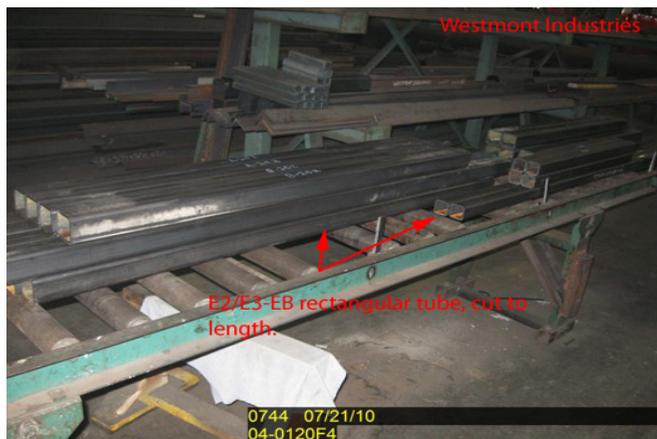
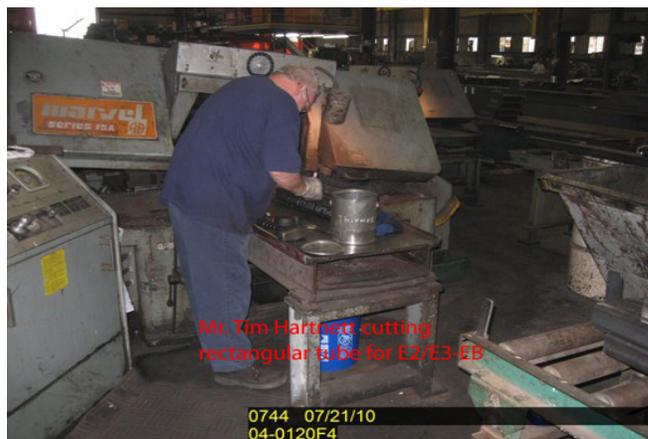
The QA Inspector later observed that the final finished cut rectangular tubing, had been transferred to a laydown area in the production bay and strategically placed in piles, for future fit-up and tack welding, on the E2/E3-EB traveler rails.

The QA Inspector observed that by the end of the shift that 32 pieces of the above mentioned material had been cut and beveled and the material appeared to be in compliance with the contract requirements.

The QA Inspector also observed that the above mentioned rectangular tubing, had been previously inspected by WMI QC Inspector Rick Rodriguez and that the Mill Test Report's (MTR's) had been previously provided to the QA Inspector. See attached pictures below.
