DEPARTMENT OF TRANSPORTATION

Quality Assurance and Source Inspection

Contract #: 04-0120F4Cty: SF/ALA Rte: 80 PM: 13.2/13.9File #: 1.28**WELDING INSPECTION REPORT****Resident Engineer:** Pursell, Gary**Address:** 333 Burma Road**City:** Oakland, CA 94607**Report No:** WIR-015866**Date Inspected:** 27-Jul-2010**Project Name:** SAS Superstructure**OSM Arrival Time:** 630**Prime Contractor:** American Bridge/Fluor Enterprises, a JV**OSM Departure Time:** 1500**Contractor:** American Bridge/Fluor Enterprises, a JV**Location:** Job Site**CWI Name:** See below**CWI Present:** Yes No**Inspected CWI report:** Yes No N/A**Rod Oven in Use:** Yes No N/A**Electrode to specification:** Yes No N/A**Weld Procedures Followed:** Yes No N/A**Qualified Welders:** Yes No N/A**Verified Joint Fit-up:** Yes No N/A**Approved Drawings:** Yes No N/A**Approved WPS:** Yes No N/A**Delayed / Cancelled:** Yes No N/A**Bridge No:** 34-0006**Component:** SAS OBG**Summary of Items Observed:**

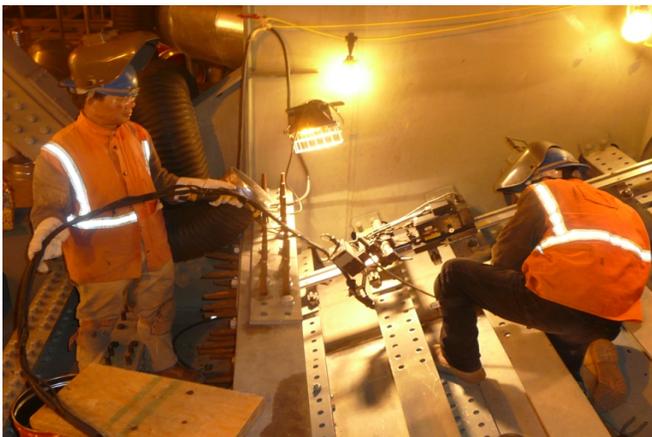
Tower Erection

The QA Inspector randomly observed the ABF erection personnel pick and set the South East and South West Shear plates. The QA Inspector randomly observed ABF set the Shear Plates on the T1 foundation over the anchor rods and snug the bolts. The QA Inspector noted the bolts were only snug tight not tensioned. The ABF Engineer John Callaghan informed the QA Inspector the South Tower Shaft will be installed tomorrow 7-28-10.
