DEPARTMENT OF TRANSPORTATION

Quality Assurance and Source Inspection

Contract #: 04-0120F4Cty: SF/ALA Rte: 80 PM: 13.2/13.9File #: 69.28**WELDING INSPECTION REPORT****Resident Engineer:** Pursell, Gary**Address:** 333 Burma Road**City:** Oakland, CA 94607**Report No:** WIR-015928**Date Inspected:** 31-Jul-2010**Project Name:** SAS Superstructure**OSM Arrival Time:** 700**Prime Contractor:** American Bridge/Fluor Enterprises, a JV**OSM Departure Time:** 1900**Contractor:** Zhenhua Port Machinery Company, Ltd (ZPMC), Changxing Island **Location:** Shanghai, China**CWI Name:** Mr. Li Jia**CWI Present:** Yes No**Inspected CWI report:** Yes No N/A**Rod Oven in Use:** Yes No N/A**Electrode to specification:** Yes No N/A**Weld Procedures Followed:** Yes No N/A**Qualified Welders:** Yes No N/A**Verified Joint Fit-up:** Yes No N/A**Approved Drawings:** Yes No N/A**Approved WPS:** Yes No N/A**Delayed / Cancelled:** Yes No N/A**Bridge No:** 34-0006**Component:** Orthotropic Box Girder (OBG)**Summary of Items Observed:**

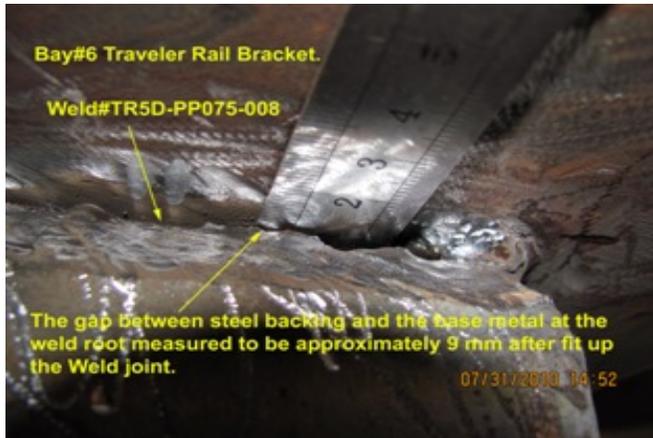
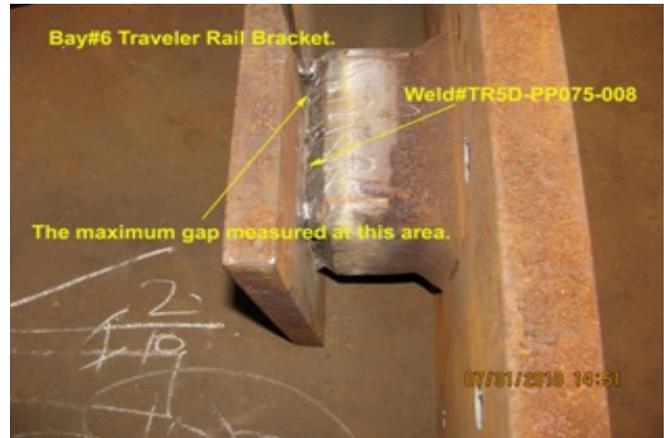
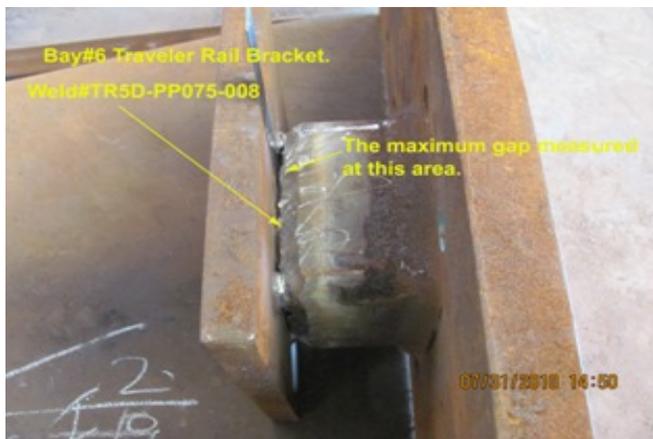
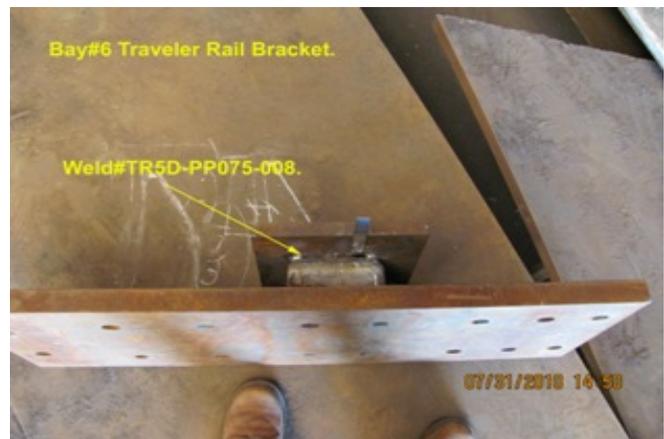
During random in process inspection of OBG Traveler Rail bracket weld joint is identified as TR5D-PP075-008, this QA observed the gap between steel backing and the base metal at the weld root approximately 9 mm after fit up the weld joint. This QA marked the affected area and informed ZPMC Quality Control (QC) identified as Mr. Shen Jian Guo and American Bridge/Fluor (AB/F) QA Inspector Mr. Lui Lai Quan of this issue. Mr. Shen Jian Guo and Mr. Lui Lai Quan informed this QA that the gap would be corrected in a manner compliant with the contract documents prior to start the welding. Refer the attached photos for further information.
