Contract #: 04-0120F4Cty: SF/ALA Rte: 80 PM: 13.2/13.9File #: 69.28**WELDING INSPECTION REPORT****Resident Engineer:** Pursell, Gary**Address:** 333 Burma Road**City:** Oakland, CA 94607**Report No:** WIR-015943**Date Inspected:** 24-Jul-2010**Project Name:** SAS Superstructure**OSM Arrival Time:** 700**Prime Contractor:** American Bridge/Fluor Enterprises, a JV**OSM Departure Time:** 1900**Contractor:** Zhenhua Port Machinery Company, Ltd (ZPMC), Changxing Island **Location:** Shanghai, China**CWI Name:** Le Zhi Jiang**CWI Present:** Yes No**Inspected CWI report:** Yes No N/A**Rod Oven in Use:** Yes No N/A**Electrode to specification:** Yes No N/A**Weld Procedures Followed:** Yes No N/A**Qualified Welders:** Yes No N/A**Verified Joint Fit-up:** Yes No N/A**Approved Drawings:** Yes No N/A**Approved WPS:** Yes No N/A**Delayed / Cancelled:** Yes No N/A**Bridge No:** 34-0006**Component:** Orthotropic Box Girder (OBG)**Summary of Items Observed:**

OBG # BAY 12

WELDING INSPECTION REPORT

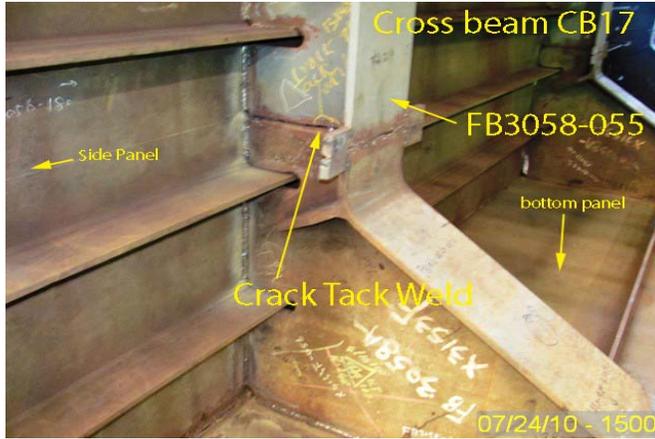
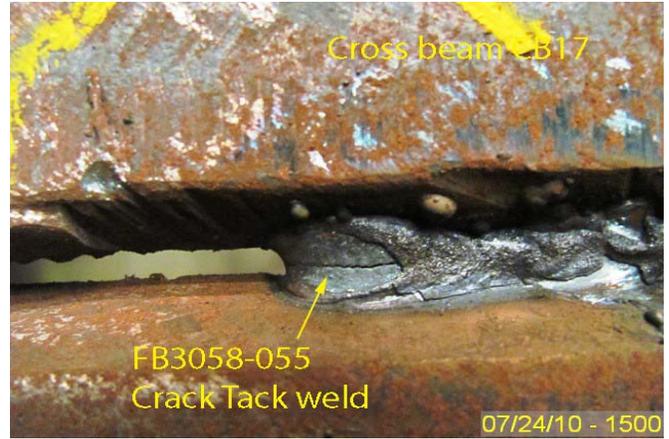
During random in process inspection of this Cross beam, this QA observed a cracked tack weld on Panel point identified as FB3058-055. This QA marked the cracked tack and informed ZPMC Quality Control (QC) identified as Mr. Feng Ya Jun of this issue. Mr. Feng Ya Jun informed this QA that the cracked tack would be corrected in a manner compliant with the contract documents. See attached pictures.
