DEPARTMENT OF TRANSPORTATION

Quality Assurance and Source Inspection

Contract #: 04-0120F4Cty: SF/ALA Rte: 80 PM: 13.2/13.9File #: 69.28**WELDING INSPECTION REPORT****Resident Engineer:** Pursell, Gary**Address:** 333 Burma Road**City:** Oakland, CA 94607**Report No:** WIR-016034**Date Inspected:** 01-Aug-2010**Project Name:** SAS Superstructure**OSM Arrival Time:** 700**Prime Contractor:** American Bridge/Fluor Enterprises, a JV**OSM Departure Time:** 1900**Contractor:** Zhenhua Port Machinery Company, Ltd (ZPMC), Changxing Island **Location:** Shanghai, China**CWI Name:** Mr. Mr. Lu xian ping**CWI Present:** Yes No**Inspected CWI report:** Yes No N/A**Rod Oven in Use:** Yes No N/A**Electrode to specification:** Yes No N/A**Weld Procedures Followed:** Yes No N/A**Qualified Welders:** Yes No N/A**Verified Joint Fit-up:** Yes No N/A**Approved Drawings:** Yes No N/A**Approved WPS:** Yes No N/A**Delayed / Cancelled:** Yes No N/A**Bridge No:** 34-0006**Component:** Orthotropic Box Girder (OBG)**Summary of Items Observed:**

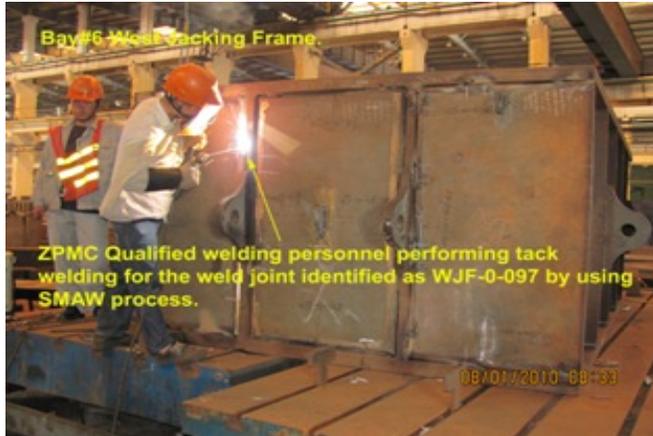
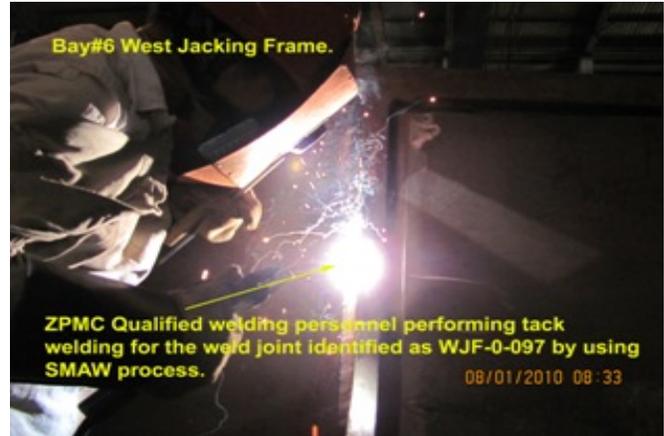
Shielded Metal Arc Welding (SMAW) Tack welding of weld joint WJF-0-097. Welder is identified as 057795. ZPMC Quality Control (QC) is identified as Mr. Zhao Jian Hang. The welding variables appeared to comply with the Applicable WPS: WPS-B-T-3313-TC-P5. Refer the attached photos for reference.
