Contract #: 04-0120F4Cty: SF/ALA Rte: 80 PM: 13.2/13.9File #: 69.28**WELDING INSPECTION REPORT****Resident Engineer:** Pursell, Gary**Address:** 333 Burma Road**City:** Oakland, CA 94607**Report No:** WIR-016054**Date Inspected:** 04-Aug-2010**Project Name:** SAS Superstructure**OSM Arrival Time:** 700**Prime Contractor:** American Bridge/Fluor Enterprises, a JV**OSM Departure Time:** 1900**Contractor:** Zhenhua Port Machinery Company, Ltd (ZPMC), Changxing Island **Location:** Shanghai, China**CWI Name:** Li Yang**CWI Present:** Yes No**Inspected CWI report:** Yes No N/A**Rod Oven in Use:** Yes No N/A**Electrode to specification:** Yes No N/A**Weld Procedures Followed:** Yes No N/A**Qualified Welders:** Yes No N/A**Verified Joint Fit-up:** Yes No N/A**Approved Drawings:** Yes No N/A**Approved WPS:** Yes No N/A**Delayed / Cancelled:** Yes No N/A**Bridge No:** 34-0006**Component:** OBG Components**Summary of Items Observed:**

On this date Caltrans OSM Quality Assurance (QA) Inspector, Dan Hernandez was present during the times noted above to observe the fit up, welding and related activities associated with the fabrication of the San Francisco Oakland Bay Self Anchored Suspension B

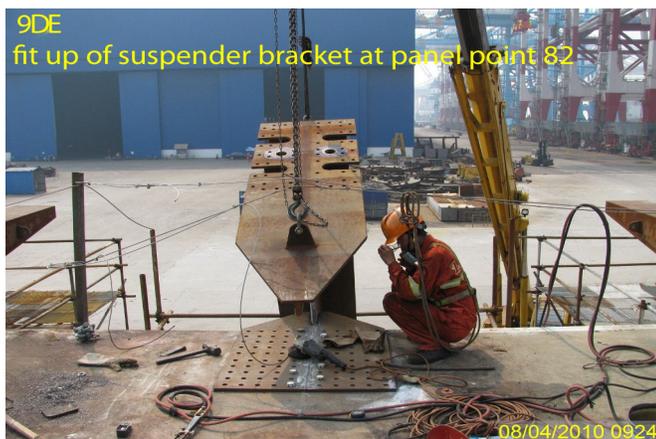
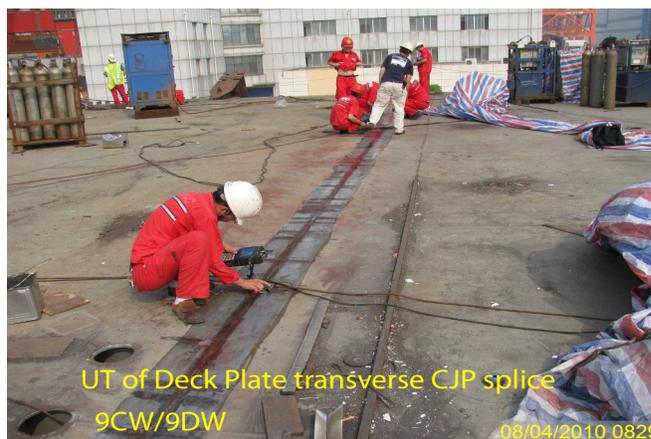
This QA Inspector observed ZPMC personnel performing Ultrasonic Testing on the Deck Plate transverse CJP splice, D scan was performed.

This QA Inspector observed the fit up of the Suspender Bracket at panel point 82.
