Contract #: 04-0120F4Cty: SF/ALA Rte: 80 PM: 13.2/13.9File #: 69.28**WELDING INSPECTION REPORT****Resident Engineer:** Pursell, Gary**Address:** 333 Burma Road**City:** Oakland, CA 94607**Report No:** WIR-016055**Date Inspected:** 04-Aug-2010**Project Name:** SAS Superstructure**OSM Arrival Time:** 700**Prime Contractor:** American Bridge/Fluor Enterprises, a JV**OSM Departure Time:** 1900**Contractor:** Zhenhua Port Machinery Company, Ltd (ZPMC), Changxing Island **Location:** Shanghai, China**CWI Name:** Zhu Zhong Hai**CWI Present:** Yes No**Inspected CWI report:** Yes No N/A**Rod Oven in Use:** Yes No N/A**Electrode to specification:** Yes No N/A**Weld Procedures Followed:** Yes No N/A**Qualified Welders:** Yes No N/A**Verified Joint Fit-up:** Yes No N/A**Approved Drawings:** Yes No N/A**Approved WPS:** Yes No N/A**Delayed / Cancelled:** Yes No N/A**Bridge No:** 34-0006**Component:** OBG Trial Assembly**Summary of Items Observed:**

Orthotropic Box Girder (OBG) Trial Assembly Areas

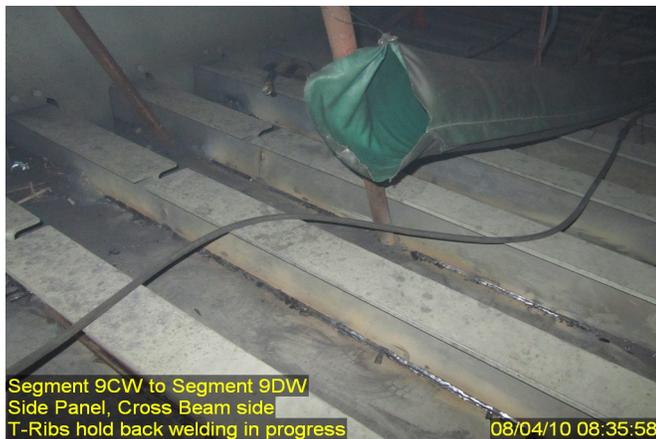
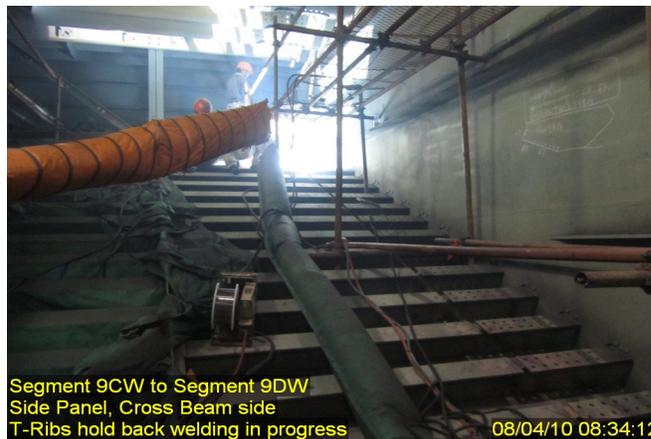
This QA Inspector observed the in-process welding by Shielded Metal Arc Welding (SMAW) process on a Complete Joint Penetration (CJP) groove weld. The Weld joint was designated as SP108-001-051, SP108-001-053, SP108-001-055, SP108-001-57, SP108-001-59 and SP108-001-61. The welder identification was 066038 and was observed welding in the 4G (Overhead) position using approved Welding Procedure Specification WPS-B-P-2214-B-U2-FCM-1. The piece mark was identified as the Side Panel T-Ribs web to web, Counter Weight side. Please reference the pictures attached for more comprehensive details.
