Contract #: 04-0120F4Cty: SF/ALA Rte: 80 PM: 13.2/13.9File #: 69.28**WELDING INSPECTION REPORT****Resident Engineer:** Pursell, Gary**Address:** 333 Burma Road**City:** Oakland, CA 94607**Report No:** WIR-016093**Date Inspected:** 05-Aug-2010**Project Name:** SAS Superstructure**OSM Arrival Time:** 645**Prime Contractor:** American Bridge/Fluor Enterprises, a JV**OSM Departure Time:** 1845**Contractor:** Zhenhua Port Machinery Company, Ltd (ZPMC), Changxing Island **Location:** Shanghai, China**CWI Name:** Yang Bai Qian.**CWI Present:** Yes No**Inspected CWI report:** Yes No N/A**Rod Oven in Use:** Yes No N/A**Electrode to specification:** Yes No N/A**Weld Procedures Followed:** Yes No N/A**Qualified Welders:** Yes No N/A**Verified Joint Fit-up:** Yes No N/A**Approved Drawings:** Yes No N/A**Approved WPS:** Yes No N/A**Delayed / Cancelled:** Yes No N/A**Bridge No:** 34-0006**Component:** Orthotropic Box Girder (OBG)**Summary of Items Observed:**

Subassembly, Bay 04, 13BE, Deck Panel U-ribs.

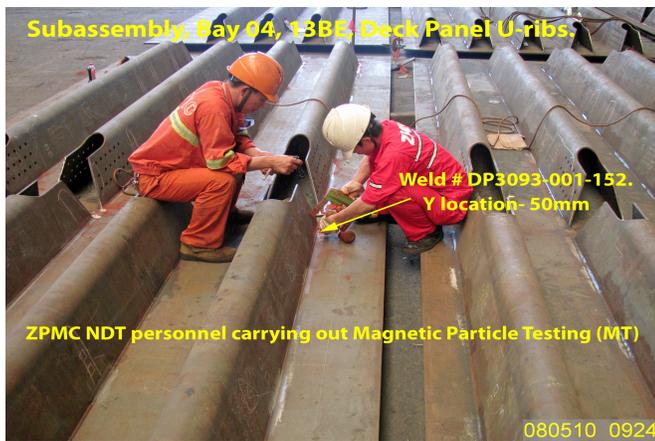
During Random Visual in process Inspection, this QA inspector observed ZPMC NDT personnel "Yuan Tao" carrying out Magnetic Particle Testing (MT) on Deck panel to U-rib welds. Deck Panel identified as DP3093-001. The attached photographs provide additional detail.
