**DEPARTMENT OF TRANSPORTATION**

Contract #: 04-0120F4Cty: SF/ALA Rte: 80 PM: 13.2/13.9File #: 69.28**WELDING INSPECTION REPORT****Resident Engineer:** Pursell, Gary**Address:** 333 Burma Road**City:** Oakland, CA 94607**Report No:** WIR-016134**Date Inspected:** 10-Aug-2010**Project Name:** SAS Superstructure**OSM Arrival Time:** 700**Prime Contractor:** American Bridge/Fluor Enterprises, a JV**OSM Departure Time:** 1900**Contractor:** Zhenhua Port Machinery Company, Ltd (ZPMC), Changxing Island **Location:** Shanghai, China**CWI Name:** Li yang.**CWI Present:** Yes No**Inspected CWI report:** Yes No N/A**Rod Oven in Use:** Yes No N/A**Electrode to specification:** Yes No N/A**Weld Procedures Followed:** Yes No N/A**Qualified Welders:** Yes No N/A**Verified Joint Fit-up:** Yes No N/A**Approved Drawings:** Yes No N/A**Approved WPS:** Yes No N/A**Delayed / Cancelled:** Yes No N/A**Bridge No:** 34-0006**Component:** OBG components.**Summary of Items Observed:**

On this day CALTRANS OSM Quality Assurance Inspector (QA) Mr. Shailesh Wadkar was present during the times noted above for observations relative to the fabrication of the Self Anchored Suspension (SAS) Superstructure being p

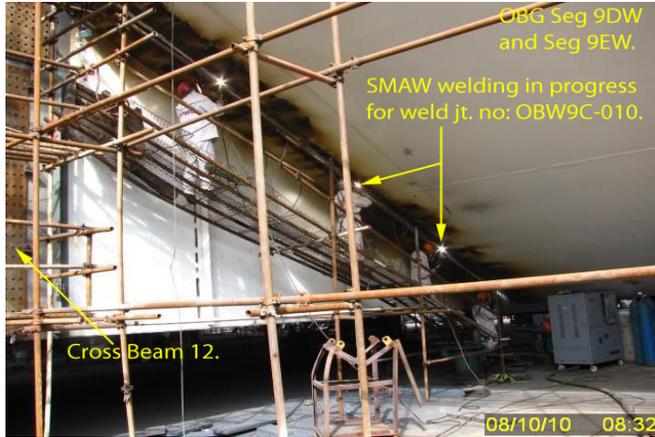
The Shielded Metal Arc Welding (SMAW) process on weld joint no: OBW9C-010. The welders are identified as 067665, 066258, 067572 and 066038 and was observed welding in the 4G position. ZPMC Quality Control (QC) was identified as Zhou Pan. The welding variables recorded by QC appeared to comply with WPS: B-P-2214-B-U2-F-1. See attached photo for further details.
