DEPARTMENT OF TRANSPORTATION

Quality Assurance and Source Inspection

Contract #: 04-0120F4Cty: SF/ALA Rte: 80 PM: 13.2/13.9File #: 69.28**WELDING INSPECTION REPORT****Resident Engineer:** Pursell, Gary**Address:** 333 Burma Road**City:** Oakland, CA 94607**Report No:** WIR-016144**Date Inspected:** 05-Aug-2010**Project Name:** SAS Superstructure**OSM Arrival Time:** 700**Prime Contractor:** American Bridge/Fluor Enterprises, a JV**OSM Departure Time:** 1900**Contractor:** Zhenhua Port Machinery Company, Ltd (ZPMC), Changxing Island **Location:** Shanghai, China**CWI Name:** Zhu Zhong Hai**CWI Present:** Yes No**Inspected CWI report:** Yes No N/A**Rod Oven in Use:** Yes No N/A**Electrode to specification:** Yes No N/A**Weld Procedures Followed:** Yes No N/A**Qualified Welders:** Yes No N/A**Verified Joint Fit-up:** Yes No N/A**Approved Drawings:** Yes No N/A**Approved WPS:** Yes No N/A**Delayed / Cancelled:** Yes No N/A**Bridge No:** 34-0006**Component:** Orthotropic Box Girder (OBG)**Summary of Items Observed:**

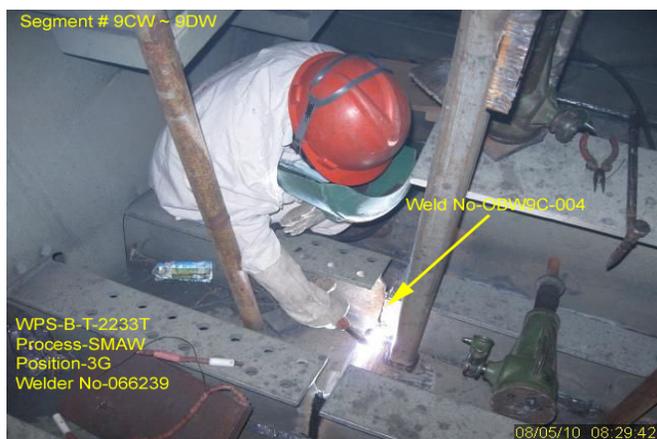
This QA inspector observed, ZPMC qualified welding personnel identified as 066239 perform Flux Core Arc Welding (FCAW), weld joint identified as OBW9C-004; ZPMC QC is identified as Mr. Shi Lei. The welding parameters measured using QC's calibrated instrument appeared to be in general compliance with WPS-B-T-2233T. See the attached photo.

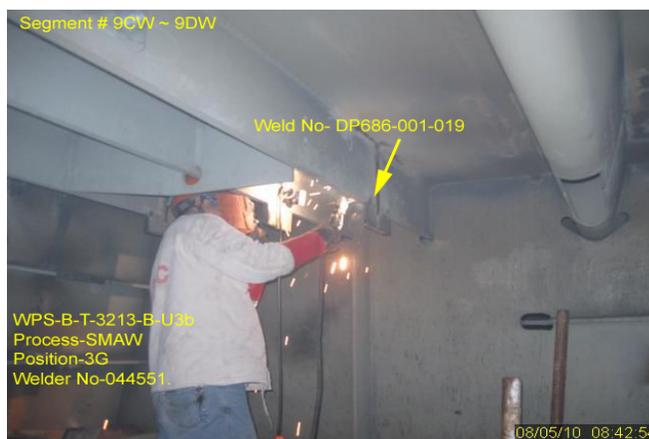
This QA inspector observed, ZPMC qualified welding personnel identified as 044551 perform Shielded Metal Arc Welding (SMAW), weld joint identified as DP686-001-019; ZPMC QC is identified as Mr. Shi Lei. The welding parameters measured using QC's calibrated instrument appeared to be in general compliance with WPS-B-T-3213-B-U3b. See the attached photo.
