DEPARTMENT OF TRANSPORTATION

Quality Assurance and Source Inspection

Contract #: 04-0120F4Cty: SF/ALA Rte: 80 PM: 13.2/13.9File #: 69.28**WELDING INSPECTION REPORT****Resident Engineer:** Pursell, Gary**Address:** 333 Burma Road**City:** Oakland, CA 94607**Report No:** WIR-016221**Date Inspected:** 12-Aug-2010**Project Name:** SAS Superstructure**OSM Arrival Time:** 700**Prime Contractor:** American Bridge/Fluor Enterprises, a JV**OSM Departure Time:** 1900**Contractor:** Zhenhua Port Machinery Company, Ltd (ZPMC), Changxing Island **Location:** Shanghai, China**CWI Name:** Xu Tao/Wu shi guo**CWI Present:** Yes No**Inspected CWI report:** Yes No N/A**Rod Oven in Use:** Yes No N/A**Electrode to specification:** Yes No N/A**Weld Procedures Followed:** Yes No N/A**Qualified Welders:** Yes No N/A**Verified Joint Fit-up:** Yes No N/A**Approved Drawings:** Yes No N/A**Approved WPS:** Yes No N/A**Delayed / Cancelled:** Yes No N/A**Bridge No:** 34-0006**Component:** OBG**Summary of Items Observed:**

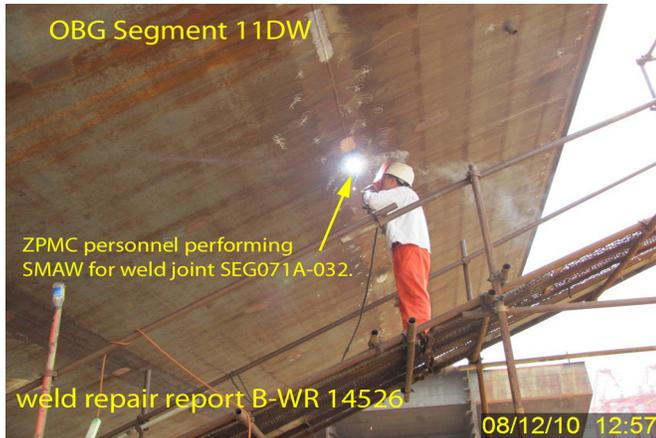
SMAW welding of weld joint no: SEG071A-032 located on OBG Segment 11DW Side panel to Side panel.

Welder is identified as #045263. ZPMC CWI is identified as Mr. Wu shi guo. Welding was performed according to the weld repair report B-WR14526 and UT report number: B787-UT-14406. The welding variables recorded by QC appeared to comply with the WPS-345-SMAW-4G(4F)-FCM-Repair-1. Please see the attached picture.

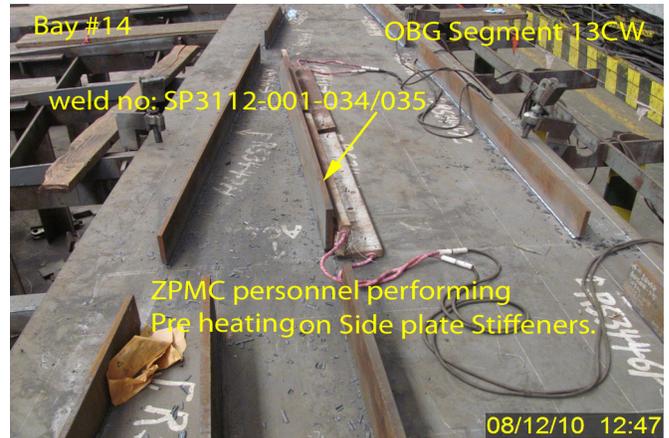
FCAW in the 2F position for the OBG Segment 13CW Side plate, weld no: SP3112-001-034/035. The welders are identified as #044830/050242. ZPMC QC is identified as Mr. Guo xing hui. The welding variables recorded by QC appear to comply with WPS-B-T-2132. Please see the attached picture.
