DEPARTMENT OF TRANSPORTATION

Quality Assurance and Source Inspection

Contract #: 04-0120F4Cty: SF/ALA Rte: 80 PM: 13.2/13.9File #: 69.28**WELDING INSPECTION REPORT****Resident Engineer:** Pursell, Gary**Address:** 333 Burma Road**City:** Oakland, CA 94607**Report No:** WIR-016223**Date Inspected:** 13-Aug-2010**Project Name:** SAS Superstructure**OSM Arrival Time:** 700**Prime Contractor:** American Bridge/Fluor Enterprises, a JV**OSM Departure Time:** 1900**Contractor:** Zhenhua Port Machinery Company, Ltd (ZPMC), Changxing Island **Location:** Shanghai, China**CWI Name:** Liu Yang**CWI Present:** Yes No**Inspected CWI report:** Yes No N/A**Rod Oven in Use:** Yes No N/A**Electrode to specification:** Yes No N/A**Weld Procedures Followed:** Yes No N/A**Qualified Welders:** Yes No N/A**Verified Joint Fit-up:** Yes No N/A**Approved Drawings:** Yes No N/A**Approved WPS:** Yes No N/A**Delayed / Cancelled:** Yes No N/A**Bridge No:** 34-0006**Component:** TOWER**Summary of Items Observed:**

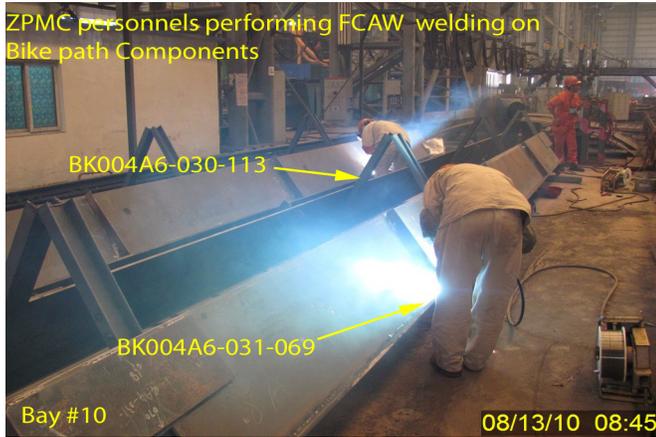
FCAW in the 1F position for the Bike path, weld No: BK004A6-030-113. The welder is identified as #040533. ZPMC QC is identified as Mr. Yuan hui gang. The welding variables recorded by QC appear to comply with WPS-B-T-2131. Please see the attached picture.
