**DEPARTMENT OF TRANSPORTATION**

Contract #: 04-0120F4Cty: SF/ALA Rte: 80 PM: 13.2/13.9File #: 1.28**WELDING INSPECTION REPORT****Resident Engineer:** Pursell, Gary**Address:** 333 Burma Road**City:** Oakland, CA 94607**Report No:** WIR-016242**Date Inspected:** 16-Aug-2010**Project Name:** SAS Superstructure**OSM Arrival Time:** 700**Prime Contractor:** American Bridge/Fluor Enterprises, a JV**OSM Departure Time:** 1530**Contractor:** American Bridge/Fluor Enterprises, a JV**Location:** Jobsite**CWI Name:** See below**CWI Present:** Yes No**Inspected CWI report:** Yes No N/A**Rod Oven in Use:** Yes No N/A**Electrode to specification:** Yes No N/A**Weld Procedures Followed:** Yes No N/A**Qualified Welders:** Yes No N/A**Verified Joint Fit-up:** Yes No N/A**Approved Drawings:** Yes No N/A**Approved WPS:** Yes No N/A**Delayed / Cancelled:** Yes No N/A**Bridge No:** 34-0006**Component:** SAS OBG**Summary of Items Observed:**

# WELDING INSPECTION REPORT

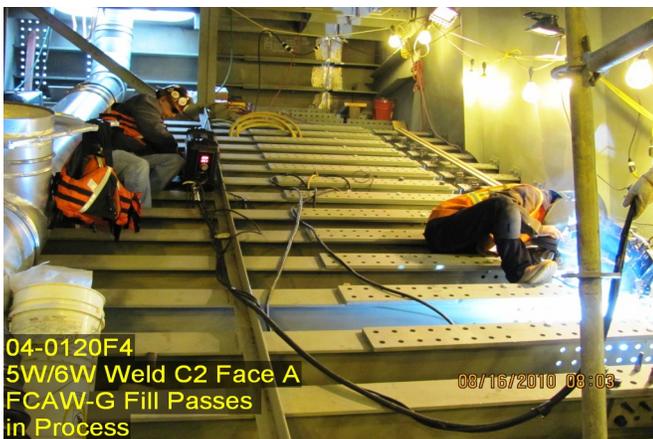
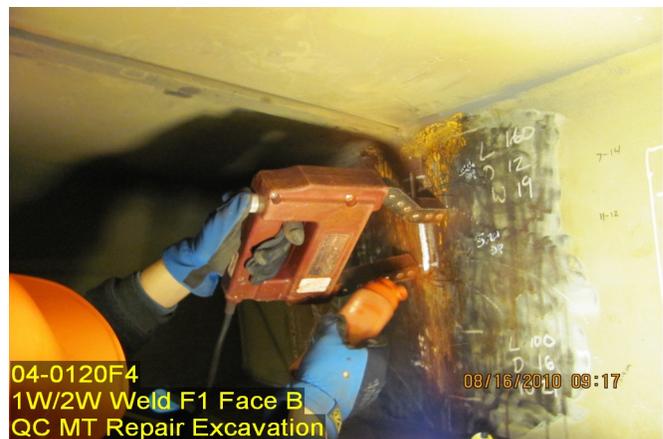
The QAI observed that there were two separate excavations in the B face of the splice weld and the QAI gauged the depths at 3mm and 5mm deep. See Summary of Conversations below. The QAI periodically observed AB/F approved welder Fred Kaddu (ID 2188) performing grinding to prepare the excavated Ultrasonic Testing (UT) repairs

(R-3) for welding. The QAI observed QC Inspector Tom Pasqualone performing Magnetic Particle Testing (MT) of the excavations prior to repair welding. See photo below. The QAI observed that the performance and evaluation of the MT appeared to comply with the MT procedure identified as SE-MT-CT-D1.5-101 Rev. 4. The QAI periodically observed AB/F approved welder Fred Kaddu (ID 2188) performing repair welding per the Shielded Metal Arc Welding (SMAW) process in the 3G (vertical) position. The QAI also periodically observed the QC Inspector Tom Pasqualone was present to monitor the progress and verify that the welding parameters were within the limits established by the approved Welding Procedure Specification (WPS) identified as ABF-WPS-D1.5-1000-Repair. Work at this location was completed and appeared to be in general compliance with

The QAI in a conversation with the QC Inspector Tom Pasqualone was informed by QC that the QC UT report showed the two indication's depths as 15mm and 18mm deep from the A face. The QC Inspector allowed the QAI to observe the QC UT Report and the QAI observed that the 15mm deep flaw was plotted in the second leg of soundpath.
