**DEPARTMENT OF TRANSPORTATION**

Contract #: 04-0120F4Cty: SF/ALA Rte: 80 PM: 13.2/13.9File #: 69.28**WELDING INSPECTION REPORT****Resident Engineer:** Pursell, Gary**Address:** 333 Burma Road**City:** Oakland, CA 94607**Report No:** WIR-016291**Date Inspected:** 07-Aug-2010**Project Name:** SAS Superstructure**OSM Arrival Time:** 1900**Prime Contractor:** American Bridge/Fluor Enterprises, a JV**OSM Departure Time:** 700**Contractor:** Zhenhua Port Machinery Company, Ltd (ZPMC), Changxing Island **Location:** Shanghai, China**CWI Name:** See Below**CWI Present:** Yes No**Inspected CWI report:** Yes No N/A**Rod Oven in Use:** Yes No N/A**Electrode to specification:** Yes No N/A**Weld Procedures Followed:** Yes No N/A**Qualified Welders:** Yes No N/A**Verified Joint Fit-up:** Yes No N/A**Approved Drawings:** Yes No N/A**Approved WPS:** Yes No N/A**Delayed / Cancelled:** Yes No N/A**Bridge No:** 34-0006**Component:** OBG**Summary of Items Observed:**

**OBG Segment Trial Assembly**

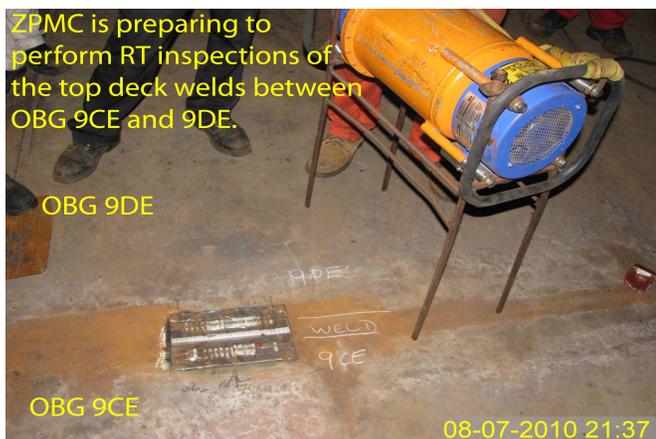
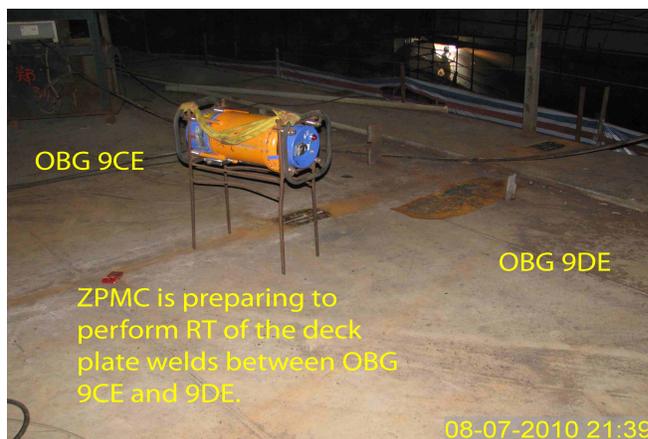
ZPMC radiography personnel informed this QA Inspector that ZPMC was going to perform radiography (RT) inspections of the top deck welds between OBG segments 9CE / 9DE and segment 9DE / 9EE starting tonight at around 22:00 hours. ZPMC normally issues and tapes a copy of radiography notification sheets to inform personnel of the locations and times that radiography will be performed. This QA Inspector observed that ZPMC has not taped a copy of this radiography notification near the bottom of the Caltrans Office stairway. For additional information see the photographs below showing ZPMC preparing to commence radiography inspections.
