Contract #: 04-0120F4Cty: SF/ALA Rte: 80 PM: 13.2/13.9File #: 82.28**WELDING INSPECTION REPORT****Resident Engineer:** Pursell, Gary**Address:** 333 Burma Road**City:** Oakland, CA 94607**Report No:** WIR-016305**Date Inspected:** 06-Aug-2010**Project Name:** SAS Superstructure**OSM Arrival Time:** 500**Prime Contractor:** American Bridge/Fluor Enterprises, a JV**OSM Departure Time:** 1330**Contractor:** Westmont Industries**Location:** Santa Fe Springs, CA.

Bridge No: 34-0006**Component:** Travelers**Summary of Items Observed:**

Traveler E2/E3-EB

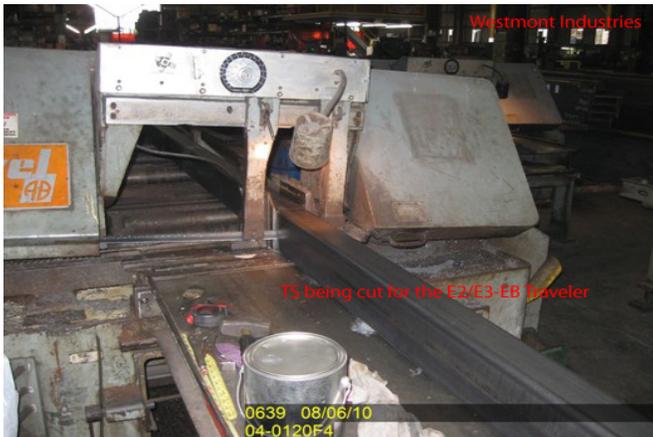
The QA Inspector observed that Mr. Harnett continued cutting TS material throughout the shift and observed that the following material was cut and identified, for the E2/E3-EB Traveler:

- 2 each-piece mark CS- 6" x 3" x .3125" x 201.75" (152 mm x 76 mm x 8 mm x 5124 mm) Rectangular TS
- 4 each-piece mark CW- 6" x 3" x .3125" x 16.875" (152 mm x 76 mm x 8 mm x 429 mm) Rectangular TS
- 2 each-piece mark B249- 6" x 3" x .3125" x 19.750" (152 mm x 76 mm x 8 mm x 502 mm) Rectangular TS
- 2 each-piece mark G250- 6" x 3" x .3125" x 9.8125" (152 mm x 76 mm x 8 mm x 249 mm) Rectangular TS
- 2 each-piece mark B251- 6" x 3" x .3125" x 68.250" (152 mm x 76 mm x 8 mm x 1734 mm) Rectangular TS

The QA Inspector verified the dimensions of the above mentioned, cut to length TS material, per the shop drawings and the material appeared to be in compliance. See attached picture below.
