DEPARTMENT OF TRANSPORTATION

Contract #: 04-0120F4Cty: SF/ALA Rte: 80 PM: 13.2/13.9File #: 69.28**WELDING INSPECTION REPORT****Resident Engineer:** Pursell, Gary**Address:** 333 Burma Road**City:** Oakland, CA 94607**Report No:** WIR-016395**Date Inspected:** 17-Aug-2010**Project Name:** SAS Superstructure**OSM Arrival Time:** 700**Prime Contractor:** American Bridge/Fluor Enterprises, a JV**OSM Departure Time:** 1900**Contractor:** Zhenhua Port Machinery Company, Ltd (ZPMC), Changxing Island **Location:** Shanghai, China**CWI Name:** Le Zhi Jiang**CWI Present:** Yes No**Inspected CWI report:** Yes No N/A**Rod Oven in Use:** Yes No N/A**Electrode to specification:** Yes No N/A**Weld Procedures Followed:** Yes No N/A**Qualified Welders:** Yes No N/A**Verified Joint Fit-up:** Yes No N/A**Approved Drawings:** Yes No N/A**Approved WPS:** Yes No N/A**Delayed / Cancelled:** Yes No N/A**Bridge No:** 34-0006**Component:** Orthotropic Box Girder (OBG)**Summary of Items Observed:**

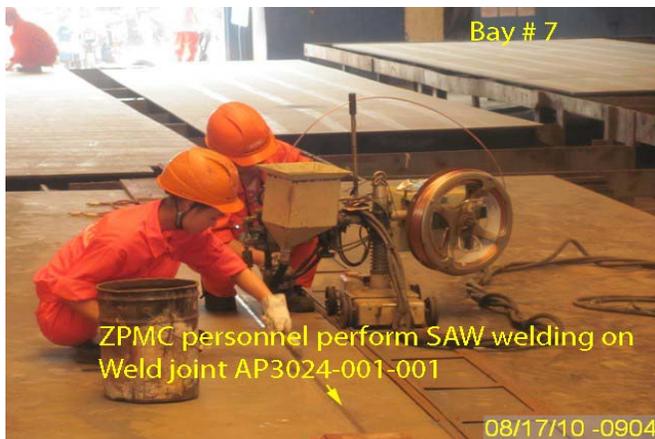
This QA observed ZPMC qualified welding personnel identified as 054458 perform Submerged Arc Welding (SAW) Process on weld joint AP3024-001-001. ZPMC Quality Control Personnel (QC) identified as Mr. Wang Liang was present to monitor the welding process. The welding parameters as measured using QC's calibrated instruments appeared to be in general compliance with WPS-B-T-2221-B-L2C-S-2. See attached pictures.
