**DEPARTMENT OF TRANSPORTATION**

Contract #: 04-0120F4Cty: SF/ALA Rte: 80 PM: 13.2/13.9File #: 1.28**WELDING INSPECTION REPORT****Resident Engineer:** Pursell, Gary**Address:** 333 Burma Road**City:** Oakland, CA 94607**Report No:** WIR-016470**Date Inspected:** 25-Aug-2010**Project Name:** SAS Superstructure**OSM Arrival Time:** 630**Prime Contractor:** American Bridge/Fluor Enterprises, a JV**OSM Departure Time:** 1500**Contractor:** American Bridge/Fluor Enterprises, a JV**Location:** Job Site**CWI Name:** See below**CWI Present:** Yes No**Inspected CWI report:** Yes No N/A**Rod Oven in Use:** Yes No N/A**Electrode to specification:** Yes No N/A**Weld Procedures Followed:** Yes No N/A**Qualified Welders:** Yes No N/A**Verified Joint Fit-up:** Yes No N/A**Approved Drawings:** Yes No N/A**Approved WPS:** Yes No N/A**Delayed / Cancelled:** Yes No N/A**Bridge No:** 34-0006**Component:** SAS OBG**Summary of Items Observed:**

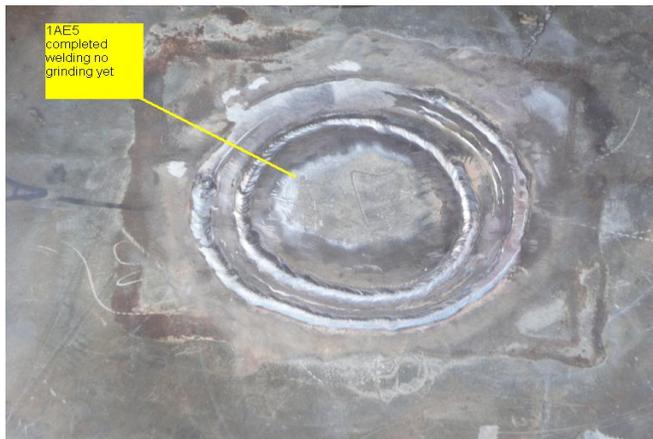
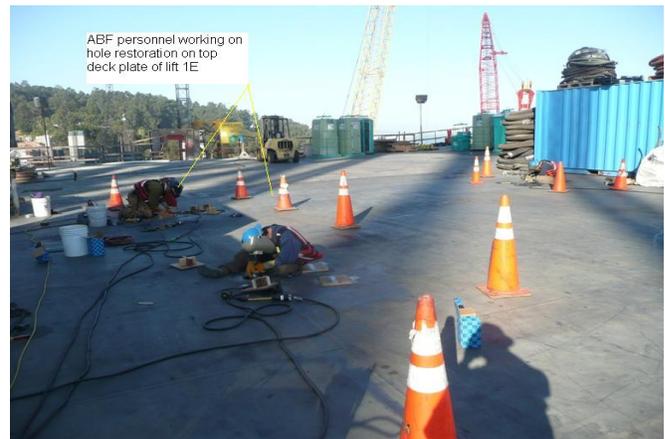
The QA Inspector randomly observed the ABF welder preheat the area to approximately 100°F prior to performing any SMAW. After the minimum required preheat had been achieved, the QA Inspector randomly observed the ABF welder begin the SMAW root pass. The QA Inspector noted the Smith Emery (SE) Quality Control (QC) Inspector Mike Johnson was on site to monitor and record the in process production welding at the above identified location. The QA Inspector randomly observed the SMAW parameters to be approximately 130 Amps with 5/32" E7018 low hydrogen electrodes. The QA Inspector randomly observed the in process welding parameters and dimensional tolerances appeared to be in general compliance with the approved welding procedure identified as ABF-WPS-D1.5-1050-A. The QA Inspector noted the ABF welder did not complete the SMAW on the QA Inspectors shift.
