**DEPARTMENT OF TRANSPORTATION**

Contract #: 04-0120F4Cty: SF/ALA Rte: 80 PM: 13.2/13.9File #: 69.28**WELDING INSPECTION REPORT****Resident Engineer:** Pursell, Gary**Address:** 333 Burma Road**City:** Oakland, CA 94607**Report No:** WIR-016501**Date Inspected:** 22-Aug-2010**Project Name:** SAS Superstructure**OSM Arrival Time:** 700**Prime Contractor:** American Bridge/Fluor Enterprises, a JV**OSM Departure Time:** 1900**Contractor:** Zhenhua Port Machinery Company, Ltd (ZPMC), Changxing Island **Location:** Shanghai, China

**Bridge No:** 34-0006**Component:** Tower**Summary of Items Observed:**

**Heavy Dock Jetty**

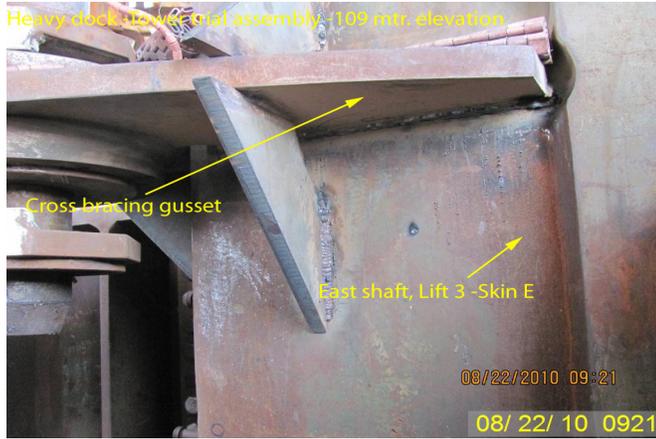
1. This QA inspector, Baskar Govindarajan, observed, ZPMC qualified welding personnel identified as 058026 perform SMAW welding on; Cross Bracing Gusset and Skin E of East shaft, Lift 3, in 109 mtr. elevation and the weld joint is identified as WD1-GUSA3-3-109 mtr.-E-4B. ZPMC CWI Identified as Mr. Zhu Feng. The welding parameters as measured using QC's calibrated instruments appeared to be in general compliance with WPS-B-T-2214-TC-U5B-FCM. (Photo attached)

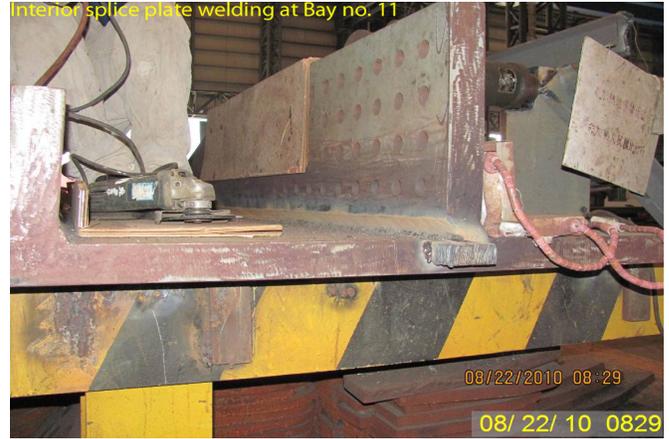
4. This QA inspector, Baskar Govindarajan, observed, ZPMC qualified welding personnel identified as 202100 perform SMAW welding on; Interior splice plate and the weld joint is identified as ESD1-SPSA5-20-1B. ZPMC CWI Identified as Mr. Yu Dong ping. The welding parameters as measured using QC's calibrated instruments appeared to be in general compliance with WPS-B-T-3212-TC-U5b-1. (Photo attached)
