**DEPARTMENT OF TRANSPORTATION**

Contract #: 04-0120F4Cty: SF/ALA Rte: 80 PM: 13.2/13.9File #: 69.28**WELDING INSPECTION REPORT****Resident Engineer:** Pursell, Gary**Address:** 333 Burma Road**City:** Oakland, CA 94607**Report No:** WIR-016512**Date Inspected:** 23-Aug-2010**Project Name:** SAS Superstructure**OSM Arrival Time:** 700**Prime Contractor:** American Bridge/Fluor Enterprises, a JV**OSM Departure Time:** 1900**Contractor:** Zhenhua Port Machinery Company, Ltd (ZPMC), Changxing Island **Location:** Shanghai, China**CWI Name:** Mr. Xu Le Feng**CWI Present:** Yes No**Inspected CWI report:** Yes No N/A**Rod Oven in Use:** Yes No N/A**Electrode to specification:** Yes No N/A**Weld Procedures Followed:** Yes No N/A**Qualified Welders:** Yes No N/A**Verified Joint Fit-up:** Yes No N/A**Approved Drawings:** Yes No N/A**Approved WPS:** Yes No N/A**Delayed / Cancelled:** Yes No N/A**Bridge No:** 34-0006**Component:** Tower and Orthotropic Box Girder (OBG)**Summary of Items Observed:**

## WELDING INSPECTION REPORT

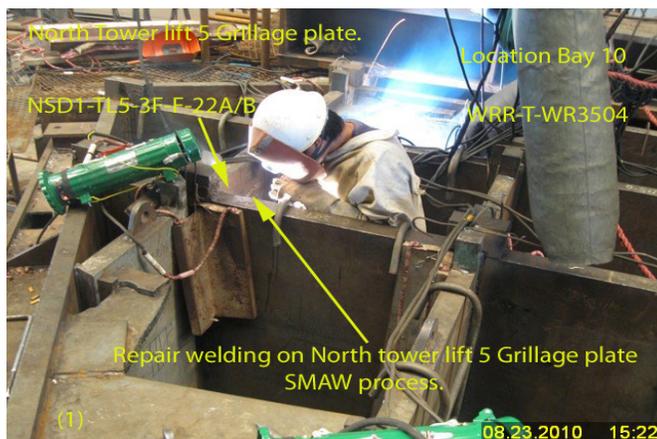
This QA Inspector observed ZPMC qualified welding personnel identified as 066236 Perform Shielded Metal Arc Welding (SMAW) on North Tower lift 5 Grillage plate. Joint identified as NSD1-TL5-3F-F-22A/B, ZPMC QC Identified as Yu Zhi Lai with temporary welding repair report WRR-T-WR3504. The welding parameters as measured using QC's calibrated instrument appeared to be in general compliance with WPS-485-SMAW-3G (3F)-Repair. For more information see below attached picture number 1.

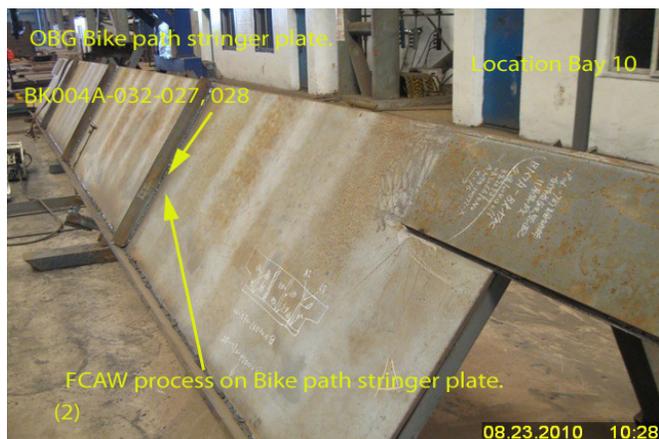
This QA Inspector observed ZPMC qualified welding personnel identified as 057180, Perform Flux core Arc Welding (FCAW) on OBG Bike path Stringer plate, Joint identified as BK004A-032-033, 034, 027, 028. ZPMC QC Identified as Ma Qianli Ma. The welding parameters as measured using QC's calibrated instrument appeared to be in general compliance with WPS-B-T-2133. For more information see below attached picture number 2.
