DEPARTMENT OF TRANSPORTATION

Quality Assurance and Source Inspection

Contract #: 04-0120F4Cty: SF/ALA Rte: 80 PM: 13.2/13.9File #: 69.28**WELDING INSPECTION REPORT****Resident Engineer:** Pursell, Gary**Address:** 333 Burma Road**City:** Oakland, CA 94607**Report No:** WIR-016518**Date Inspected:** 26-Aug-2010**Project Name:** SAS Superstructure**OSM Arrival Time:** 700**Prime Contractor:** American Bridge/Fluor Enterprises, a JV**OSM Departure Time:** 1900**Contractor:** Zhenhua Port Machinery Company, Ltd (ZPMC), Changxing Island **Location:** Shanghai, China**CWI Name:** Mr. Xu Le Feng**CWI Present:** Yes No**Inspected CWI report:** Yes No N/A**Rod Oven in Use:** Yes No N/A**Electrode to specification:** Yes No N/A**Weld Procedures Followed:** Yes No N/A**Qualified Welders:** Yes No N/A**Verified Joint Fit-up:** Yes No N/A**Approved Drawings:** Yes No N/A**Approved WPS:** Yes No N/A**Delayed / Cancelled:** Yes No N/A**Bridge No:** 34-0006**Component:** Tower and Orthotropic Box Girder (OBG)**Summary of Items Observed:**

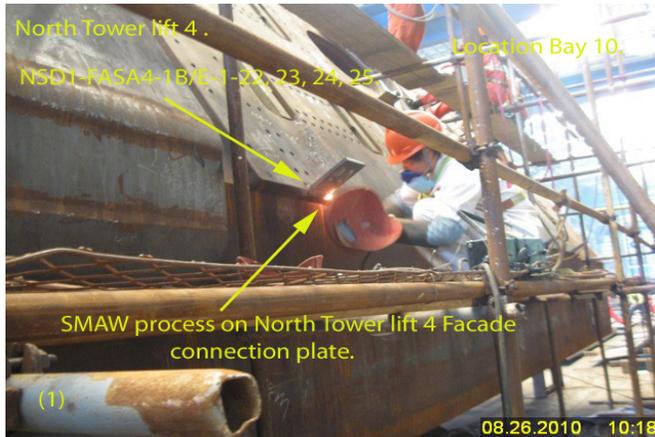
This QA Inspector observed ZPMC qualified welding personnel identified as 056364, Perform Shielded Metal Arc Welding (SMAW) on North Tower lift 4 Façade connection plate. Joint identified as NSD1-FASA4-1B/E-6, 7, 8, 9, NSD1-FASA4-1B/E-1-22, 23, 24, 25, NSD1-FASA4-1B/E-2-22, 23, 24, 25. ZPMC QC Identified as Lijun. The welding parameters as measured using QC's calibrated instrument appeared to be in general compliance with WPS-B-P-4111, 4114 and WPS-B-T-4314-Tc-P4. For more information see below attached picture number 1.

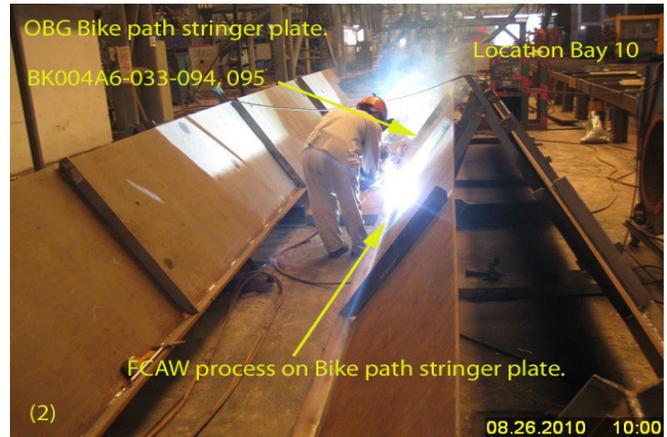
This QA Inspector observed ZPMC qualified welding personnel identified as 052075, 053116, Perform Flux core Arc Welding (FCAW) on OBG Bike path stringer plate, Joint identified as BK004A6-033-094, 095 and BK004A7-033-101, 102, 107, 108, 099, 100. ZPMC QC Identified as Sun Tian Liang. The welding parameters as measured using QC's calibrated instrument appeared to be in general compliance with WPS-B-T-2131, 2133. For more information see below attached picture number 2.
