DEPARTMENT OF TRANSPORTATION

Quality Assurance and Source Inspection

Contract #: 04-0120F4Cty: SF/ALA Rte: 80 PM: 13.2/13.9File #: 69.28**WELDING INSPECTION REPORT****Resident Engineer:** Siegenthaler, Peter**Address:** 333 Burma Road**City:** Oakland, CA 94607**Report No:** WIR-016564**Date Inspected:** 29-Aug-2010**Project Name:** SAS Superstructure**OSM Arrival Time:** 700**Prime Contractor:** American Bridge/Fluor Enterprises, a JV**OSM Departure Time:** 1900**Contractor:** Zhenhua Port Machinery Company, Ltd (ZPMC), Changxing Island **Location:** Shanghai, China**CWI Name:** Mr. Huang min**CWI Present:** Yes No**Inspected CWI report:** Yes No N/A**Rod Oven in Use:** Yes No N/A**Electrode to specification:** Yes No N/A**Weld Procedures Followed:** Yes No N/A**Qualified Welders:** Yes No N/A**Verified Joint Fit-up:** Yes No N/A**Approved Drawings:** Yes No N/A**Approved WPS:** Yes No N/A**Delayed / Cancelled:** Yes No N/A**Bridge No:** 34-0006**Component:** Orthotropic Box Girder (OBG)**Summary of Items Observed:**

WELDING INSPECTION REPORT

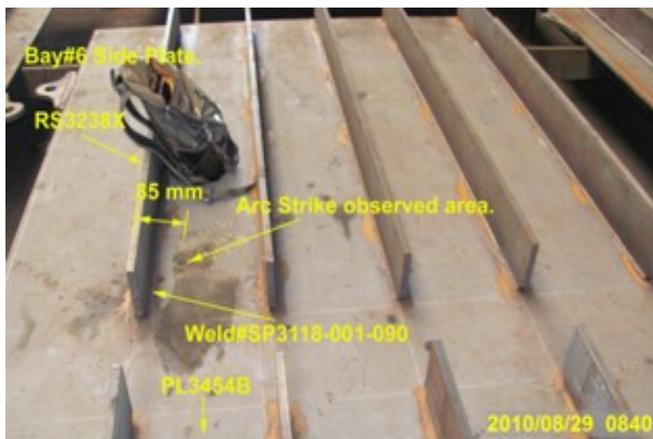
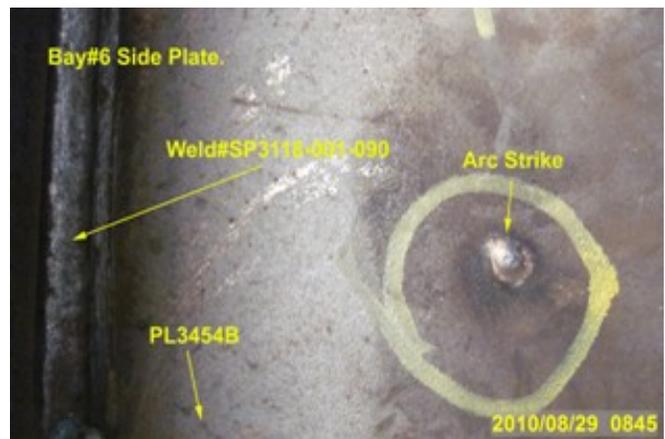
During random in process inspection of OBG member identified as SP3118-001 this QA observed an arc strike on Piece Mark (PCM) identified as PL3454B. This QA marked the affected area and informed ZPMC Quality Control (QC) identified as Mr. Huang min of this issue. Mr. Huang min informed this QA that the arc strike would be corrected in a manner compliant with the contract documents. Refer the attached photos for reference.
