**DEPARTMENT OF TRANSPORTATION**

Contract #: 04-0120F4Cty: SF/ALA Rte: 80 PM: 13.2/13.9File #: 99.28**WELDING INSPECTION REPORT****Resident Engineer:** Siegenthaler, Peter**Address:** 333 Burma Road**City:** Oakland, CA 94607**Report No:** WIR-016565**Date Inspected:** 01-Sep-2010**Project Name:** SAS Superstructure**OSM Arrival Time:** 700**Prime Contractor:** American Bridge/Fluor Enterprises, a JV**OSM Departure Time:** 1900**Contractor:** Zhenhua Port Machinery Company, Ltd (ZPMC)**Location:** Shanghai, China

Orthotropic Box Girder (OBG) at Trial Assembly Areas

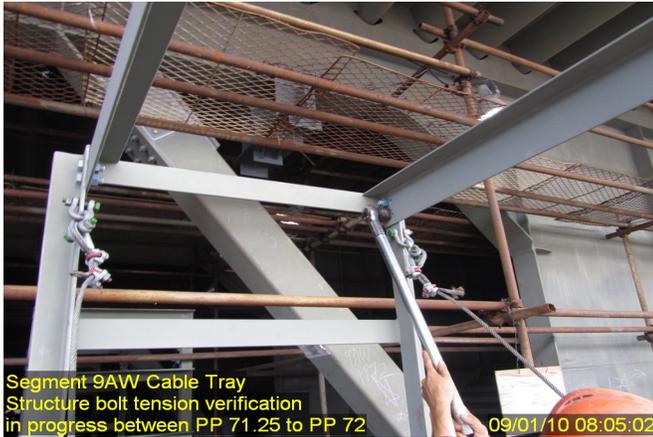
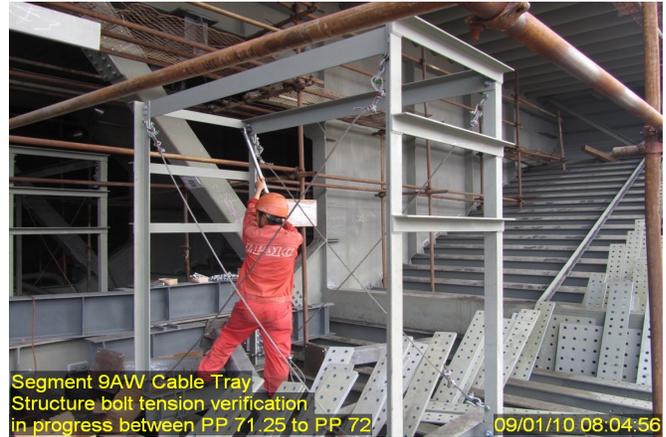
This QA Inspector witnessed the final bolt tension verification on bolts connecting the Cable Tray Structures installed at Bottom Panel T-Ribs at North and South Side between Panel Points (PP) 71.25 to PP 73 for Segment 9AW. The QA Inspector verified the bolt tension on a random basis and the results appeared to be in general compliance. The Inspection was performed against Notification No. 00471 dated Sep 01, 2010.

The bolt sizes used were M19 x 50 RC Lot # DHG60631 and the final torque value established was 346 N-m.

The Manual Torque wrench used was Serial No. XO2-114. Please reference the pictures attached for more comprehensive details.
