Contract #: 04-0120F4Cty: SF/ALA Rte: 80 PM: 13.2/13.9File #: 69.28**WELDING INSPECTION REPORT****Resident Engineer:** Siegenthaler, Peter**Address:** 333 Burma Road**City:** Oakland, CA 94607**Report No:** WIR-016627**Date Inspected:** 07-Sep-2010**Project Name:** SAS Superstructure**OSM Arrival Time:** 700**Prime Contractor:** American Bridge/Fluor Enterprises, a JV**OSM Departure Time:** 1900**Contractor:** Zhenhua Port Machinery Company, Ltd (ZPMC), Changxing Island **Location:** Shanghai, China**CWI Name:** Li Yang**CWI Present:** Yes No**Inspected CWI report:** Yes No N/A**Rod Oven in Use:** Yes No N/A**Electrode to specification:** Yes No N/A**Weld Procedures Followed:** Yes No N/A**Qualified Welders:** Yes No N/A**Verified Joint Fit-up:** Yes No N/A**Approved Drawings:** Yes No N/A**Approved WPS:** Yes No N/A**Delayed / Cancelled:** Yes No N/A**Bridge No:** 34-0006**Component:** OBG**Summary of Items Observed:**

OBG SEGMENT 12BW

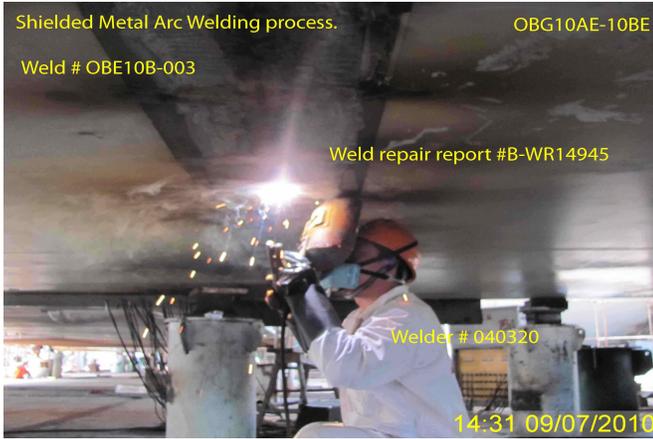
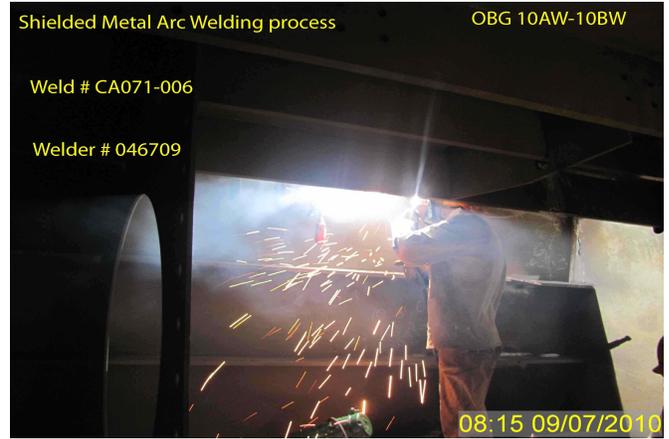
This Quality Assurance (QA) Inspector observed ZPMC qualified welder 046709 performing the Shielded Metal Arc Welding process on weld 006 located at PCMK CA071. ZPMC QC Mr. Zhou Peng was monitoring this welding operation. The welding variables recorded by QC appeared to comply with WPS-345-SMAW-4G (4F)-Fcm-Repair-1. Weld repair report identified as B-WR14936.

This Quality Assurance (QA) Inspector observed ZPMC qualified welder 040320 performing the Shielded Metal Arc Welding process on weld 003 located at PCMK OBE10B. ZPMC QC Mr. Wang Li Yang was monitoring this welding operation. The welding variables recorded by QC appeared to comply with WPS-345-SMAW-4G (4F)-Fcm-Repair-1. Weld repair report identified as B-WR14945.
