DEPARTMENT OF TRANSPORTATION

Contract #: 04-0120F4Cty: SF/ALA Rte: 80 PM: 13.2/13.9File #: 99.28**WELDING INSPECTION REPORT****Resident Engineer:** Siegenthaler, Peter**Address:** 333 Burma Road**City:** Oakland, CA 94607**Report No:** WIR-016629**Date Inspected:** 07-Sep-2010**Project Name:** SAS Superstructure**OSM Arrival Time:** 700**Prime Contractor:** American Bridge/Fluor Enterprises, a JV**OSM Departure Time:** 1900**Contractor:** Zhenhua Port Machinery Company, Ltd (ZPMC)**Location:** Shanghai, China

Orthotropic Box Girder (OBG) at Trial Assembly Areas

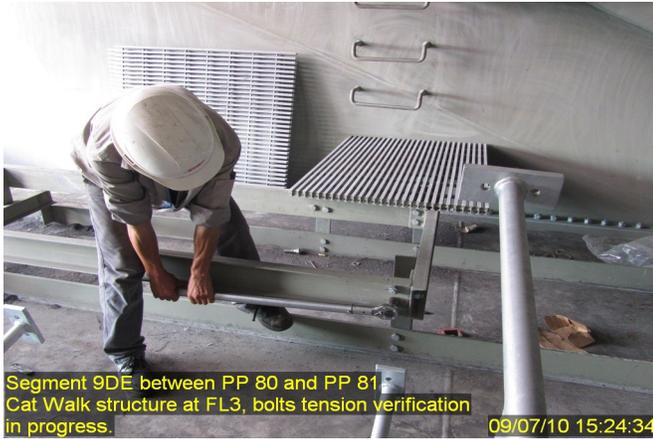
This Quality Assurance (QA) Inspector witnessed final bolt tension verification for Catwalk structure which is connected to Bottom Plate I-Ribs at FL3 area between Panel Points (PP) 80 and PP 81 for Segment 9DE.

Inspected 10% on a random basis and found the tension to be in general compliance. Inspection was performed against the Notification No. 00480 Dated September 07, 2010.

Segment 9DE between PP 80 and PP 81
Cat Walk structure at FL3, bolts tension verification
in progress. 09/07/10 15:24:34

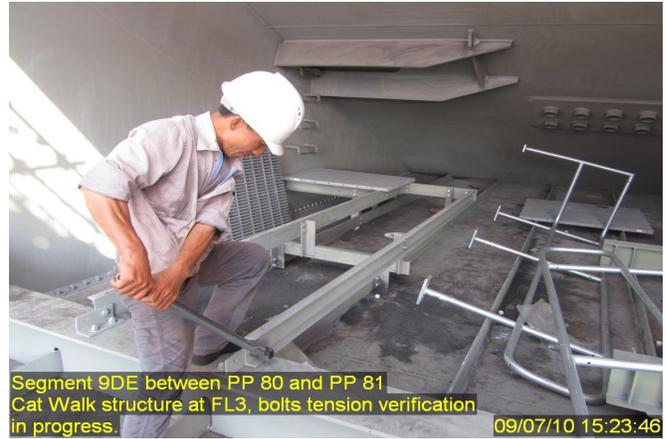
Segment 9DE between PP 80 and PP 81
Cat Walk structure at FL3, bolts tension verification
in progress. 09/07/10 15:23:46

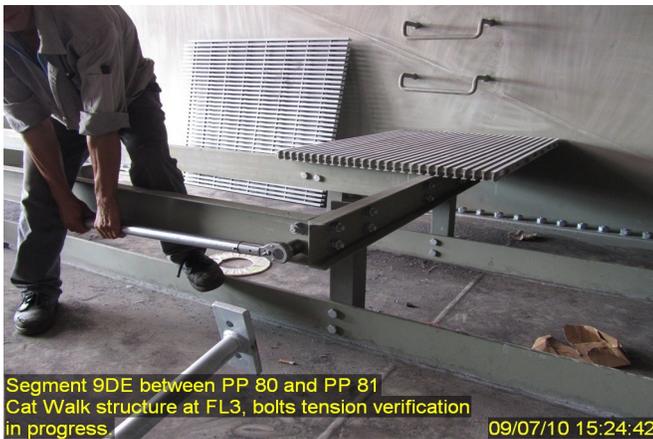
Segment 9DE between PP 80 and PP 81
Cat Walk structure at FL3, bolts tension verification
in progress. 09/07/10 15:24:42

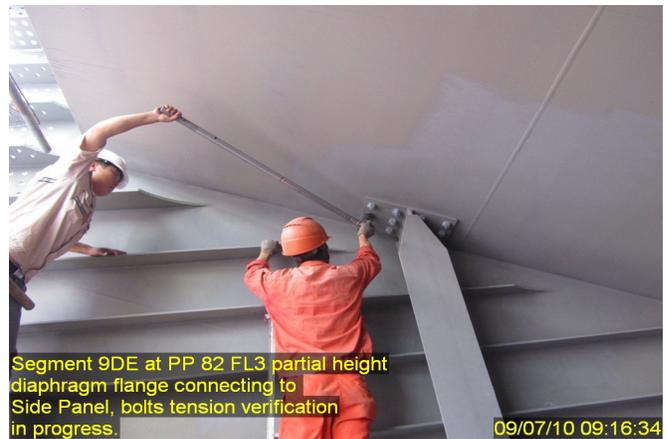
This QA Inspector witnessed the final bolt tension verification on bolts connecting the Partial Height Diaphragm flange to the Side Panel at FL3 location at Panel Points (PP) 80, PP 81 and PP 82 for Segment 9DE. The QA Inspector verified the bolt tension on a random basis and the results appeared to be in general compliance. The Inspection was performed against Notification No. 00478 dated Sep 07, 2010.

Segment 9DE at PP 82 FL3 partial height
diaphragm flange connecting to
Side Panel, bolts tension verification
in progress. 09/07/10 09:16:34

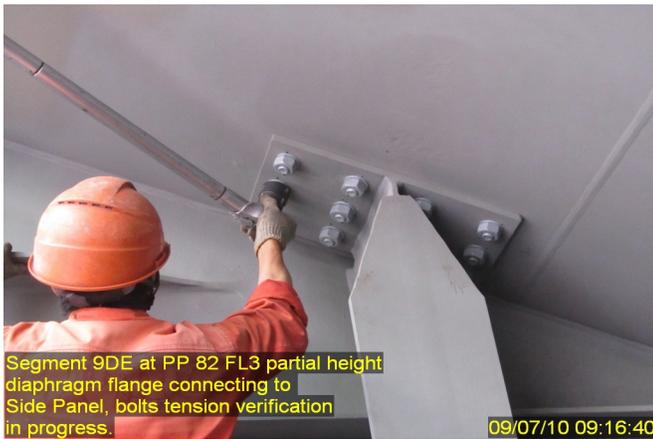
Segment 9DE at PP 82 FL3 partial height
diaphragm flange connecting to
Side Panel, bolts tension verification
in progress. 09/07/10 09:16:40
