DEPARTMENT OF TRANSPORTATION

Contract #: 04-0120F4Cty: SF/ALA Rte: 80 PM: 13.2/13.9File #: 69.28**WELDING INSPECTION REPORT****Resident Engineer:** Siegenthaler, Peter**Address:** 333 Burma Road**City:** Oakland, CA 94607**Report No:** WIR-016683**Date Inspected:** 07-Sep-2010**Project Name:** SAS Superstructure**OSM Arrival Time:** 700**Prime Contractor:** American Bridge/Fluor Enterprises, a JV**OSM Departure Time:** 1900**Contractor:** Zhenhua Port Machinery Company, Ltd (ZPMC), Changxing Island **Location:** Shanghai, China

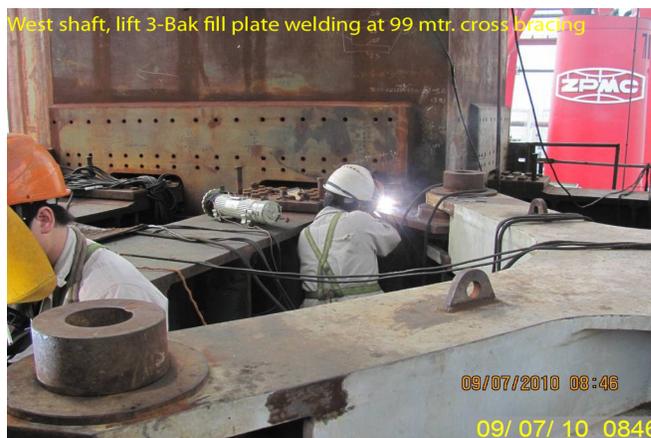
5. This QA inspector, Baskar Govindarajan, observed, ZPMC qualified welding personnel identified as 052930 perform SMAW welding on; Cross Bracing Gusset and Back fill plate on Skin A of South shaft, Lift 3, in 89 mtr. elevation and the weld joint is identified as SSD1-FASA3-1 C/E-22, 23. ZPMC CWI Identified as Mr. Ye Yong Jun. The welding parameters as measured using QC's calibrated instruments appeared to be in general compliance with WPS-B-T-4212-TC-U4C.(Photo attached)
