**DEPARTMENT OF TRANSPORTATION**

Contract #: 04-0120F4Cty: SF/ALA Rte: 80 PM: 13.2/13.9File #: 69.28**WELDING INSPECTION REPORT****Resident Engineer:** Siegenthaler, Peter**Address:** 333 Burma Road**City:** Oakland, CA 94607**Report No:** WIR-016686**Date Inspected:** 02-Sep-2010**Project Name:** SAS Superstructure**OSM Arrival Time:** 700**Prime Contractor:** American Bridge/Fluor Enterprises, a JV**OSM Departure Time:** 1900**Contractor:** Zhenhua Port Machinery Company, Ltd (ZPMC), Changxing Island **Location:** Shanghai, China**CWI Name:** Zhao Chen Sun**CWI Present:** Yes No**Inspected CWI report:** Yes No N/A**Rod Oven in Use:** Yes No N/A**Electrode to specification:** Yes No N/A**Weld Procedures Followed:** Yes No N/A**Qualified Welders:** Yes No N/A**Verified Joint Fit-up:** Yes No N/A**Approved Drawings:** Yes No N/A**Approved WPS:** Yes No N/A**Delayed / Cancelled:** Yes No N/A**Bridge No:** 34-0006**Component:** Tower Components**Summary of Items Observed:**

**TOWER JETTY**

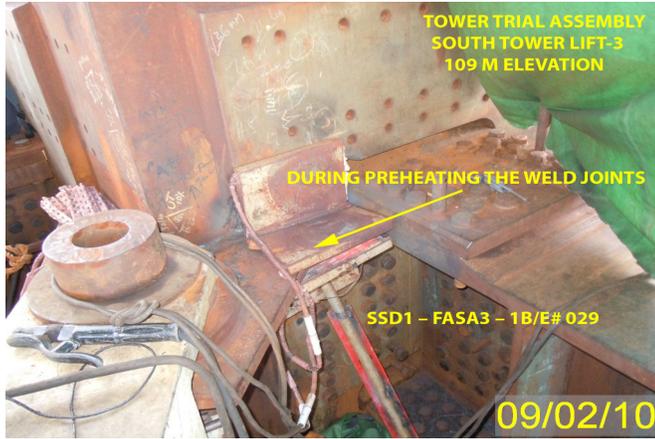
Weld joint # 29 located on South tower Lift-3, 109 M cross bracing gusset plate to small doubler plate SSD1 – FASA3 – 1B/E. Welder is identified as 040365. ZPMC Quality Control (QC) Inspector is identified Zhao Chen Sun. The welding variables recorded by QC appeared to comply with the WPS – B – P – 4214– Tc – U4c. (See attached photo)

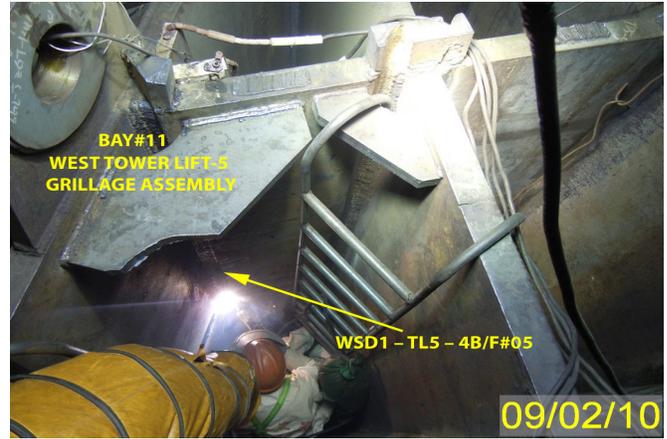
Weld joint # 05 located on West tower Lift-5 Grillage Assembly WSD1 – TL5 – 4B/F. Welder is identified as 067993. ZPMC Quality Control (QC) Inspector is identified as Shang Hai Long. The welding variables recorded by QC appeared to comply with the WPS – B – T – 3213 – Tc – U4c.

(See attached photo)
