Contract #: 04-0120F4Cty: SF/ALA Rte: 80 PM: 13.2/13.9File #: 69.28**WELDING INSPECTION REPORT****Resident Engineer:** Siegenthaler, Peter**Address:** 333 Burma Road**City:** Oakland, CA 94607**Report No:** WIR-016756**Date Inspected:** 12-Sep-2010**Project Name:** SAS Superstructure**OSM Arrival Time:** 700**Prime Contractor:** American Bridge/Fluor Enterprises, a JV**OSM Departure Time:** 1900**Contractor:** Zhenhua Port Machinery Company, Ltd (ZPMC), Changxing Island **Location:** Shanghai, China

Bridge No: 34-0006**Component:** Orthotropic Box Girder (OBG)**Summary of Items Observed:**

WELDING INSPECTION REPORT

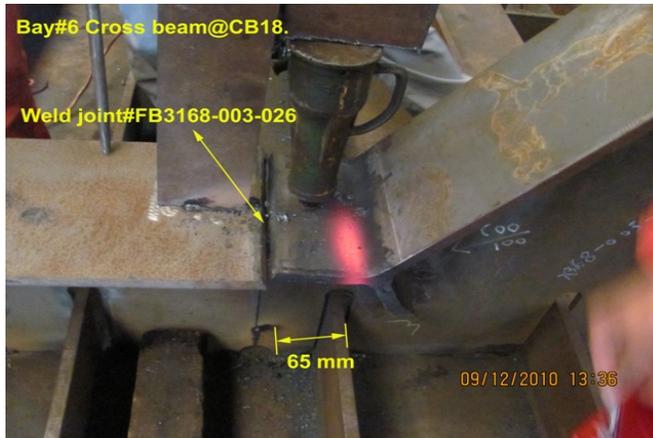
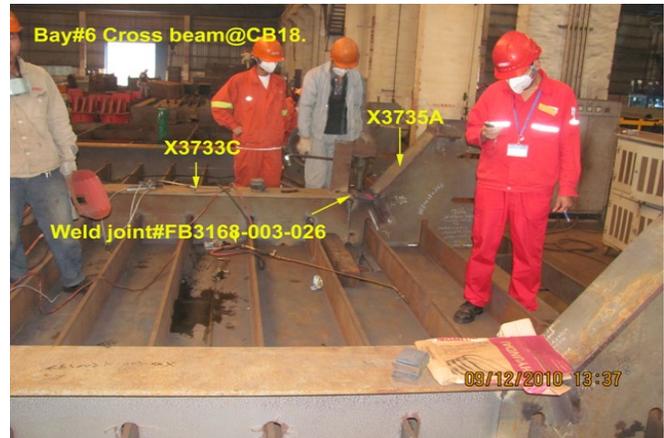
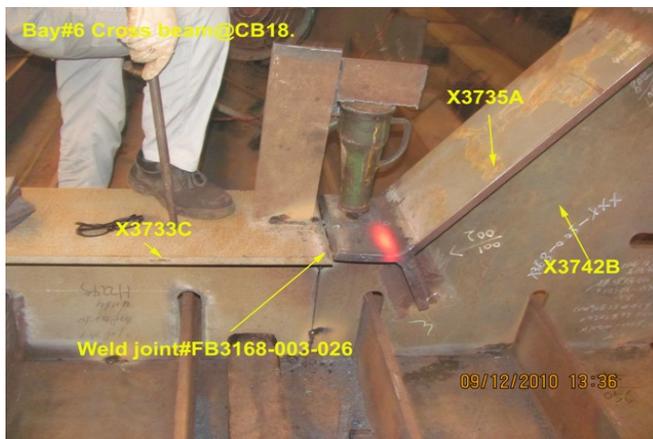
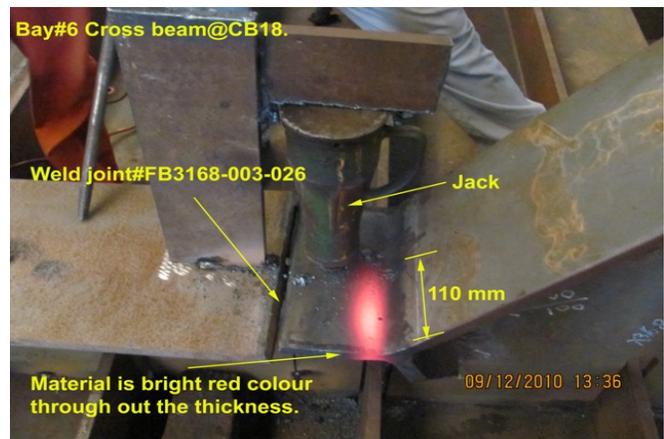
During the QA random in-process observations of the fabrication of OBG Cross beam (CB) CB18, this Caltrans QA observed during the fit up of the floor beam diaphragms on CB18 ZPMC personnel appear to have overheated the flange base metal. The material was heated to a bright red/yellow condition. AWS D1.5 2002 defines the color of material heated to 650oC as a “dull red color”. The corner diaphragm flange is identified as X3735A. The weld joint number nearest to the heated area is identified as FB3168-003-026. The area being heated is approximately 65 mm from the above mentioned weld joint. The length of the heated area is approximately 110 mm parallel to the above mentioned weld joint.

This QA generated an incident report on this date for the above issue, for further information see the incident report and attached photos.
