DEPARTMENT OF TRANSPORTATION

Quality Assurance and Source Inspection

Contract #: 04-0120F4Cty: SF/ALA Rte: 80 PM: 13.2/13.9File #: 69.28**WELDING INSPECTION REPORT****Resident Engineer:** Siegenthaler, Peter**Address:** 333 Burma Road**City:** Oakland, CA 94607**Report No:** WIR-016783**Date Inspected:** 13-Sep-2010**Project Name:** SAS Superstructure**OSM Arrival Time:** 700**Prime Contractor:** American Bridge/Fluor Enterprises, a JV**OSM Departure Time:** 1900**Contractor:** Zhenhua Port Machinery Company, Ltd (ZPMC), Changxing Island **Location:** Shanghai, China**CWI Name:** Li Yang**CWI Present:** Yes No**Inspected CWI report:** Yes No N/A**Rod Oven in Use:** Yes No N/A**Electrode to specification:** Yes No N/A**Weld Procedures Followed:** Yes No N/A**Qualified Welders:** Yes No N/A**Verified Joint Fit-up:** Yes No N/A**Approved Drawings:** Yes No N/A**Approved WPS:** Yes No N/A**Delayed / Cancelled:** Yes No N/A**Bridge No:** 34-0006**Component:** OBG**Summary of Items Observed:**

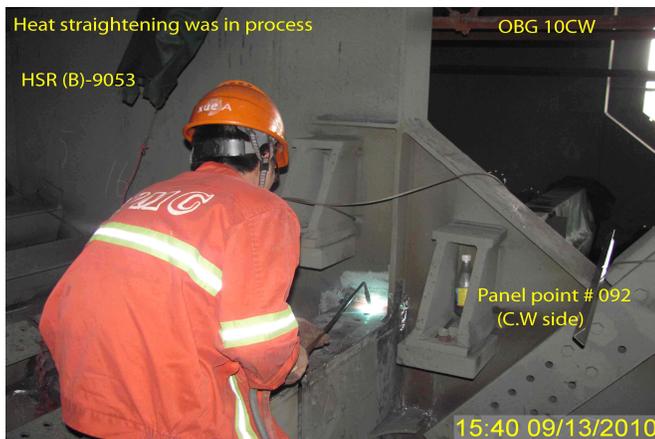
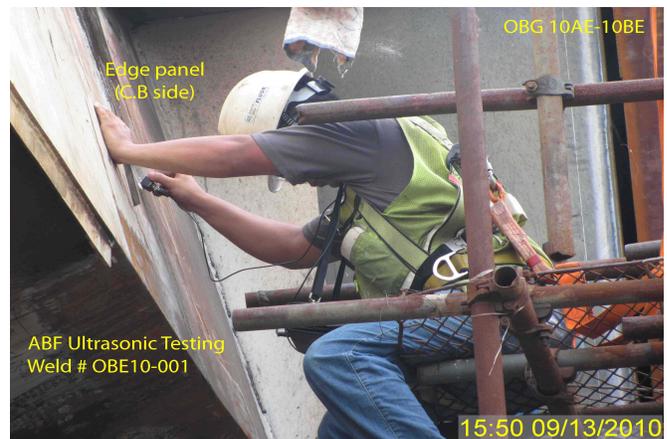
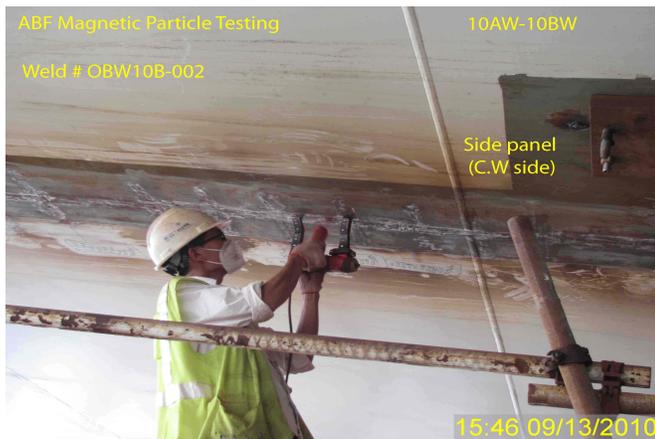
This Quality Assurance (QA) Inspector observed ABF personnel performing Ultrasonic testing at the edge panel splice weld between OBG segment 10AE and 10BE on cross beam side. Weld number identified as OBE10-001.

This Quality Assurance (QA) Inspector observed ZPMC personnel performing Magnetic Particle testing on the hold back weld between "T" stiffener and side panel on the bike path side at the side panel splice weld between OBG segment 10AE and 10BE.

This Quality Assurance (QA) Inspector observed ZPMC qualified welder 040320 performing the Shielded Metal Arc Welding process on weld 001 located at PCMK CA072. ZPMC QC Mr. Wang Li Yang was monitoring this welding operation. The welding variables recorded by QC appeared to comply with WPS-345-SMAW-4G (4F)-Fcm-Repair-1. Critical weld repair report identified as B-CWR1901.

This Quality Assurance (QA) Inspector observed ZPMC personnel performing heat straightening on the weld between longitudinal diaphragm and floor beam at PP92 on counter weight side. Heat straightening report identified as HSR (B)-9053.

This Quality Assurance (QA) Inspector observed ABF personnel performing Magnetic Particle testing at the side panel splice weld between OBG segment 10AW and 10BW on counter weight side. Weld number identified as OBW10B-002.
