DEPARTMENT OF TRANSPORTATION

Quality Assurance and Source Inspection

Contract #: 04-0120F4Cty: SF/ALA Rte: 80 PM: 13.2/13.9File #: 69.28**WELDING INSPECTION REPORT****Resident Engineer:** Siegenthaler, Peter**Address:** 333 Burma Road**City:** Oakland, CA 94607**Report No:** WIR-016791**Date Inspected:** 17-Sep-2010**Project Name:** SAS Superstructure**OSM Arrival Time:** 700**Prime Contractor:** American Bridge/Fluor Enterprises, a JV**OSM Departure Time:** 1900**Contractor:** Zhenhua Port Machinery Company, Ltd (ZPMC), Changxing Island **Location:** Shanghai, China**CWI Name:** Liu Hua Jie.**CWI Present:** Yes No**Inspected CWI report:** Yes No N/A**Rod Oven in Use:** Yes No N/A**Electrode to specification:** Yes No N/A**Weld Procedures Followed:** Yes No N/A**Qualified Welders:** Yes No N/A**Verified Joint Fit-up:** Yes No N/A**Approved Drawings:** Yes No N/A**Approved WPS:** Yes No N/A**Delayed / Cancelled:** Yes No N/A**Bridge No:** 34-0006**Component:** OBG components.**Summary of Items Observed:**

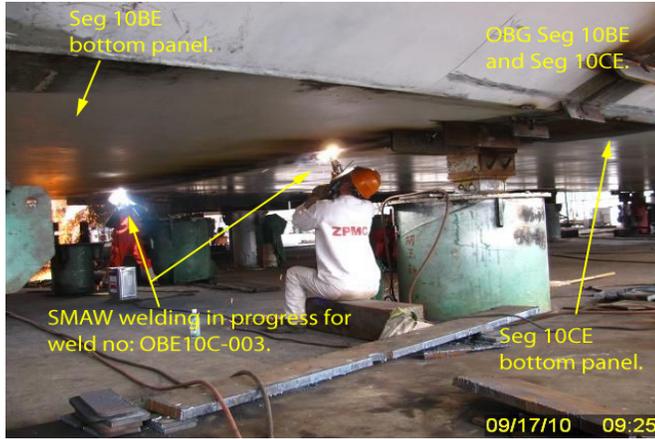
OBG Seg 10BE and Seg 10CE:

The Shielded Metal Arc Welding (SMAW) process on weld joint no: OBE10C-003. The welders are identified as 044504 and 053871 and were observed welding in the 4G position. ZPMC Quality Control (QC) was identified as Liu Hua Jie. The welding variables recorded by QC appeared to comply with WPS: B-P-2214-B-U2-FCM-1. See attached photo for further details.
