Contract #: 04-0120F4Cty: SF/ALA Rte: 80 PM: 13.2/13.9File #: 82.28**WELDING INSPECTION REPORT****Resident Engineer:** Siegenthaler, Peter**Address:** 333 Burma Road**City:** Oakland, CA 94607**Report No:** WIR-016820**Date Inspected:** 07-Sep-2010**Project Name:** SAS Superstructure**OSM Arrival Time:** 500**Prime Contractor:** American Bridge/Fluor Enterprises, a JV**OSM Departure Time:** 1330**Contractor:** Westmont Industries**Location:** Santa Fe Springs, CA.**CWI Name:** R. Rodriguez, R. Dominguez**CWI Present:** Yes No**Inspected CWI report:** Yes No N/A**Rod Oven in Use:** Yes No N/A**Electrode to specification:** Yes No N/A**Weld Procedures Followed:** Yes No N/A**Qualified Welders:** Yes No N/A**Verified Joint Fit-up:** Yes No N/A**Approved Drawings:** Yes No N/A**Approved WPS:** Yes No N/A**Delayed / Cancelled:** Yes No N/A**Bridge No:** 34-0006**Component:** Travelers**Summary of Items Observed:**

WELDING INSPECTION REPORT

Trolley Test Stand

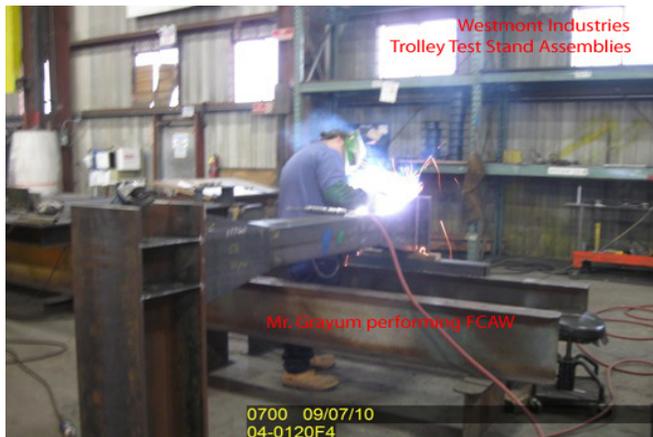
See attached picture below.

On this date, the QA Inspector observed Westmont Industries (WMI), production welder Daniel Grayum, (WID # 3048), performing welding activities, for the fabrication of the Trolley Test Rack. The QA Inspector observed Mr. Grayum utilizing the Flux Core Arc Welding (FCAW) process and that Mr. Grayum was currently qualified to perform the FCAW process. The QA Inspector observed that Mr. Grayum was utilizing a Miller brand machine and wire feeder, to perform the welding and that Ultracore 71A85 (.045") diameter wire was being utilized, for the filler metal. The QA Inspector observed that Smith-Emery QC Inspector Ruben Dominguez was present, during the welding activities and Mr. Dominguez explained that an approved Welding Procedure Specification (WPS) was being utilized to perform the FCAW. The QA Inspector observed that the tack welding was being performed on the Gusset plates and Beams, for the fabrication of the the Rail Support Beam Assembly 3-A5 (Reference Drawing # TTC-5). The QA Inspector observed that the applicable WPS's were nearby the work area and that QC Dominguez had randomly verified the welding parameters, utilizing a TPI296 Amprobe, which had a calibration date of 5/22/10. The QA Inspector observed QC Dominguez verifying pre-heat temperature, utilizing a hand held CEN-TECH Infrared Thermometer and verify the FCAW travel speed was in compliance with the applicable WPS.

The QA Inspector observed that the FCAW parameters, pre-heat temperatures and FCAW appeared to be in compliance with the WPS.
