DEPARTMENT OF TRANSPORTATION

Contract #: 04-0120F4Cty: SF/ALA Rte: 80 PM: 13.2/13.9File #: 82.28**WELDING INSPECTION REPORT****Resident Engineer:** Siegenthaler, Peter**Address:** 333 Burma Road**City:** Oakland, CA 94607**Report No:** WIR-016846**Date Inspected:** 13-Sep-2010**Project Name:** SAS Superstructure**OSM Arrival Time:** 500**Prime Contractor:** American Bridge/Fluor Enterprises, a JV**OSM Departure Time:** 1330**Contractor:** Westmont Industries**Location:** Santa Fe Springs, CA.**CWI Name:** R. Rodriguez, R. Dominguez**CWI Present:** Yes No**Inspected CWI report:** Yes No N/A**Rod Oven in Use:** Yes No N/A**Electrode to specification:** Yes No N/A**Weld Procedures Followed:** Yes No N/A**Qualified Welders:** Yes No N/A**Verified Joint Fit-up:** Yes No N/A**Approved Drawings:** Yes No N/A**Approved WPS:** Yes No N/A**Delayed / Cancelled:** Yes No N/A**Bridge No:** 34-0006**Component:** Travelers**Summary of Items Observed:**

Traveler E2/E3-EB

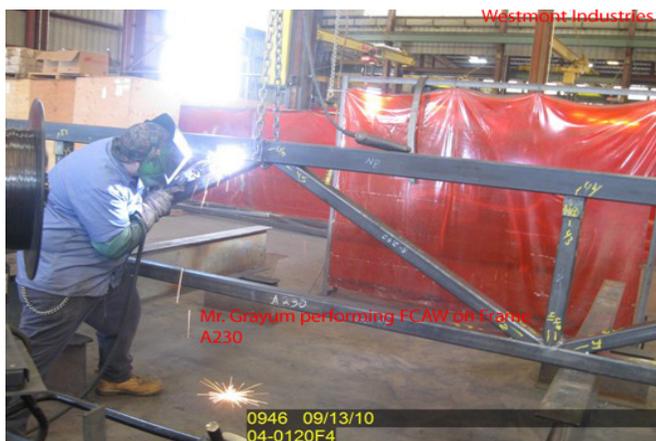
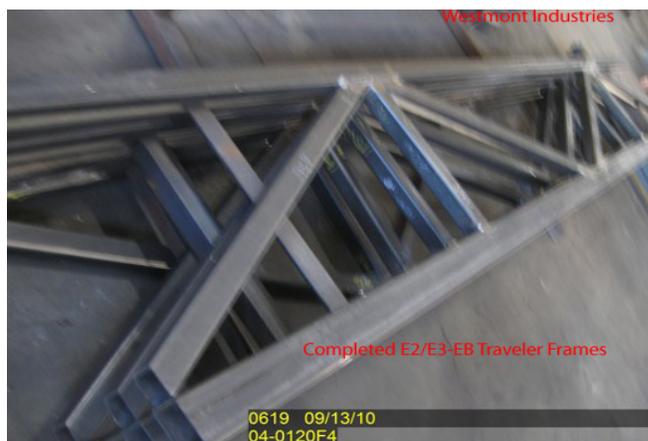
The QA Inspector observed that the above mentioned activities continued throughout the shift, appeared to be in compliance with the contract requirements and randomly observed that a total of 8 each Traveler Frame Assemblies have been completed, as of this date.

See attached pictures below.
