DEPARTMENT OF TRANSPORTATION

Quality Assurance and Source Inspection

Contract #: 04-0120F4Cty: SF/ALA Rte: 80 PM: 13.2/13.9File #: 82.28**WELDING INSPECTION REPORT****Resident Engineer:** Siegenthaler, Peter**Address:** 333 Burma Road**City:** Oakland, CA 94607**Report No:** WIR-016847**Date Inspected:** 09-Sep-2010**Project Name:** SAS Superstructure**OSM Arrival Time:** 500**Prime Contractor:** American Bridge/Fluor Enterprises, a JV**OSM Departure Time:** 1330**Contractor:** Westmont Industries**Location:** Santa Fe Springs, CA.**CWI Name:** R. Rodriguez, R. Dominguez**CWI Present:** Yes No**Inspected CWI report:** Yes No N/A**Rod Oven in Use:** Yes No N/A**Electrode to specification:** Yes No N/A**Weld Procedures Followed:** Yes No N/A**Qualified Welders:** Yes No N/A**Verified Joint Fit-up:** Yes No N/A**Approved Drawings:** Yes No N/A**Approved WPS:** Yes No N/A**Delayed / Cancelled:** Yes No N/A**Bridge No:** 34-0006**Component:** Travelers**Summary of Items Observed:**

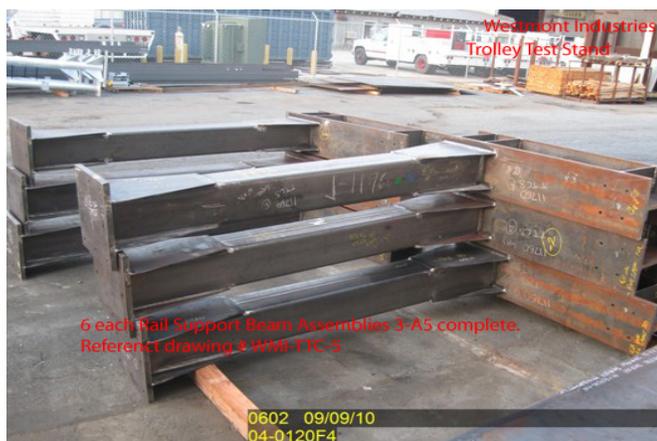
Trolley Test Stand

On this date, the QA Inspector observed QC Inspector Dominguez performing random Visual and Magnetic Particle Testing (VT/MT), on the previously completed Rail Support Assemblies, for the Trolley Test Stand. QC Inspector Dominguez explained that 100% Visual and 10% Magnetic Particle Testing was being performed on the completed welds, in accordance with AWS D1.1 2002 and the approved WMI MT Procedure SE-MT-CT.D1. 1-105, Rev1. After the testing was complete on the assemblies, QC Inspector Dominguez explained that he had found no rejectable indications. See attached picture below.
