Contract #: 04-0120F4Cty: SF/ALA Rte: 80 PM: 13.2/13.9File #: 69.28**WELDING INSPECTION REPORT****Resident Engineer:** Siegenthaler, Peter**Address:** 333 Burma Road**City:** Oakland, CA 94607**Report No:** WIR-016849**Date Inspected:** 20-Sep-2010**Project Name:** SAS Superstructure**OSM Arrival Time:** 700**Prime Contractor:** American Bridge/Fluor Enterprises, a JV**OSM Departure Time:** 1900**Contractor:** Zhenhua Port Machinery Company, Ltd (ZPMC), Changxing Island **Location:** Shanghai, China**CWI Name:** Li Yang**CWI Present:** Yes No**Inspected CWI report:** Yes No N/A**Rod Oven in Use:** Yes No N/A**Electrode to specification:** Yes No N/A**Weld Procedures Followed:** Yes No N/A**Qualified Welders:** Yes No N/A**Verified Joint Fit-up:** Yes No N/A**Approved Drawings:** Yes No N/A**Approved WPS:** Yes No N/A**Delayed / Cancelled:** Yes No N/A**Bridge No:** 34-0006**Component:** PQR HP2010119**Summary of Items Observed:**

WELDING INSPECTION REPORT

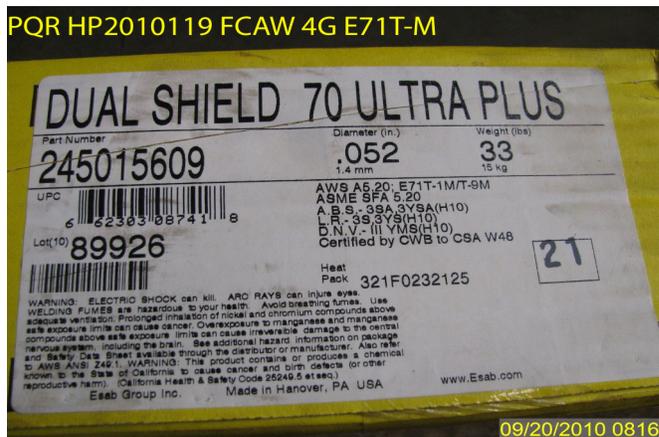
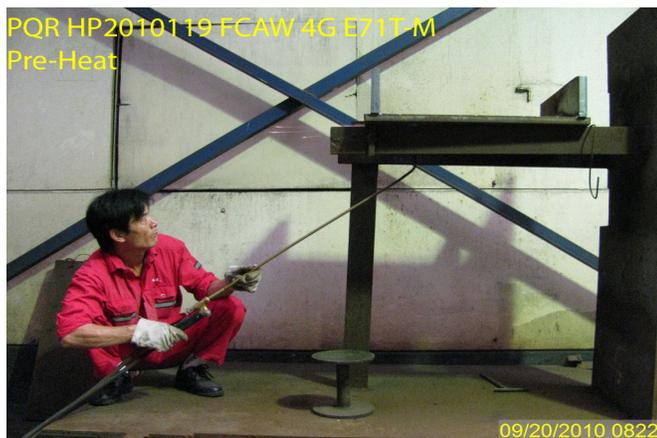
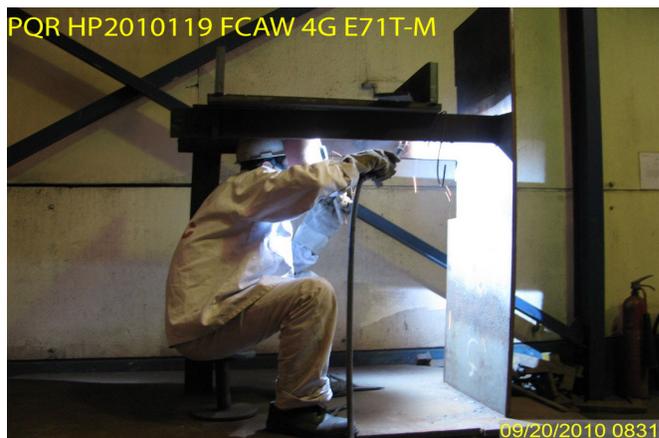
This QA Inspector observed the welding of Procedure Qualification Record (PQR) HP2010119 using the Flux Cored Arc Welding (FCAW) process in the 4G (overhead) position using ESAB E71T-M Dual Shield 70 Ultra Plus electrode. The electrode is 1.4mm in diameter, Lot # 89926. The Welding Procedure Specification (WPS) followed was PWPS-B-T-2234. The test plate configuration was a Complete Joint Penetration (CJP) Single Bevel Groove weld Butt Joint, 25mm in thickness and 700mm in length using a 10mm x 75mm backing bar. The test plate material is identified as A709 GR345. Fifteen (15) weld passes were used to complete the groove weld. The welder was identified as Zhai Da Wei.
