DEPARTMENT OF TRANSPORTATION

Contract #: 04-0120F4Cty: SF/ALA Rte: 80 PM: 13.2/13.9File #: 69.28**WELDING INSPECTION REPORT****Resident Engineer:** Siegenthaler, Peter**Address:** 333 Burma Road**City:** Oakland, CA 94607**Report No:** WIR-016893**Date Inspected:** 06-Sep-2010**Project Name:** SAS Superstructure**OSM Arrival Time:** 700**Prime Contractor:** American Bridge/Fluor Enterprises, a JV**OSM Departure Time:** 1900**Contractor:** Zhenhua Port Machinery Company, Ltd (ZPMC), Changxing Island **Location:** Shanghai, China**CWI Name:** Zhu Zhong Hai**CWI Present:** Yes No**Inspected CWI report:** Yes No N/A**Rod Oven in Use:** Yes No N/A**Electrode to specification:** Yes No N/A**Weld Procedures Followed:** Yes No N/A**Qualified Welders:** Yes No N/A**Verified Joint Fit-up:** Yes No N/A**Approved Drawings:** Yes No N/A**Approved WPS:** Yes No N/A**Delayed / Cancelled:** Yes No N/A**Bridge No:** 34-0006**Component:** Orthotropic Box Girder (OBG)**Summary of Items Observed:**

WELDING INSPECTION REPORT

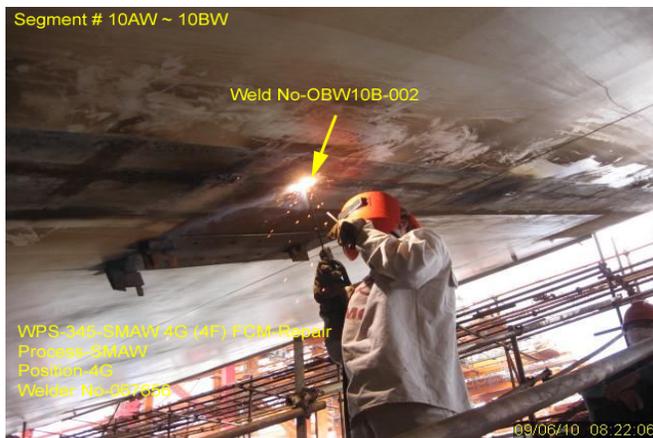
Repair Welding.

This QA inspector observed, ZPMC qualified welding personnel identified as 067656 perform Shielded Metal Arc Welding (SMAW), weld joint identified as OBW10B-002; The Welding Repair Report (WRR) was B-WR14920. ZPMC QC is identified as Mr. Wang Zhu. The welding parameters measured using QC's calibrated instrument appeared to be in general compliance with WPS-345-SMAW-4G (4F) FCM-Repair. See the attached Photo.

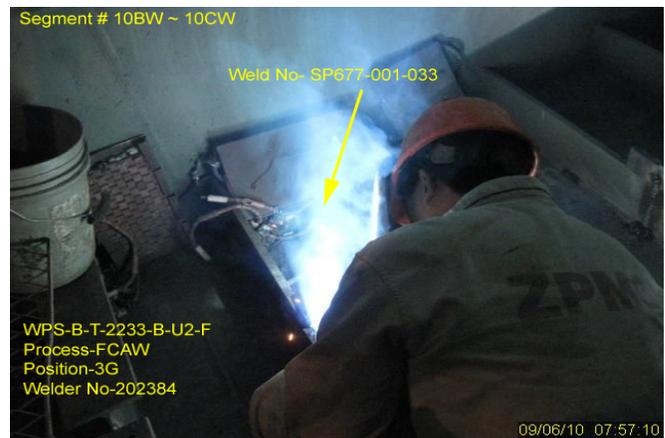
Segment # 10BW ~ 10CW

This QA inspector observed, ZPMC qualified welding personnel identified as 202384 perform Flux Core Arc Welding (FCAW), weld joint identified as SP677-001-033; ZPMC QC is identified as Mr. Wang Zhu. The welding parameters measured using QC's calibrated instrument appeared to be in general compliance with WPS-B-T-2233-B-U2-F. See the attached Photo.
