**DEPARTMENT OF TRANSPORTATION**

Contract #: 04-0120F4Cty: SF/ALA Rte: 80 PM: 13.2/13.9File #: 69.28**WELDING INSPECTION REPORT****Resident Engineer:** Siegenthaler, Peter**Address:** 333 Burma Road**City:** Oakland, CA 94607**Report No:** WIR-016904**Date Inspected:** 19-Sep-2010**Project Name:** SAS Superstructure**OSM Arrival Time:** 700**Prime Contractor:** American Bridge/Fluor Enterprises, a JV**OSM Departure Time:** 1900**Contractor:** Zhenhua Port Machinery Company, Ltd (ZPMC), Changxing Island **Location:** Shanghai, China**CWI Name:** Liu Hua Jie**CWI Present:** Yes No**Inspected CWI report:** Yes No N/A**Rod Oven in Use:** Yes No N/A**Electrode to specification:** Yes No N/A**Weld Procedures Followed:** Yes No N/A**Qualified Welders:** Yes No N/A**Verified Joint Fit-up:** Yes No N/A**Approved Drawings:** Yes No N/A**Approved WPS:** Yes No N/A**Delayed / Cancelled:** Yes No N/A**Bridge No:** 34-0006**Component:** Orthotropic Box Girder (OBG)**Summary of Items Observed:**

**OBG # TRIAL ASSEMBLY YARD**

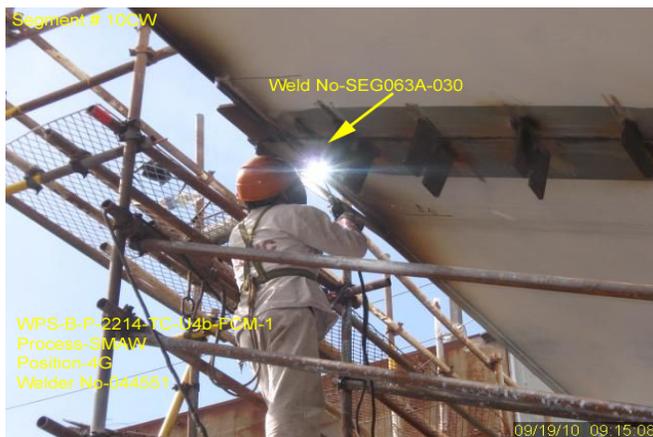
## Segment # 10CW

This QA inspector observed, ZPMC qualified welding personnel identified as 044551 perform Shielded Metal Arc Welding (SMAW), weld joint identified as SEG063A-30; ZPMC QC is identified as Mr. Zhou Peng. The welding parameters measured using QC's calibrated instrument appeared to be in general compliance with WPS-B-P-2214-TC-U4b-FCM-1. See the attached Photo.

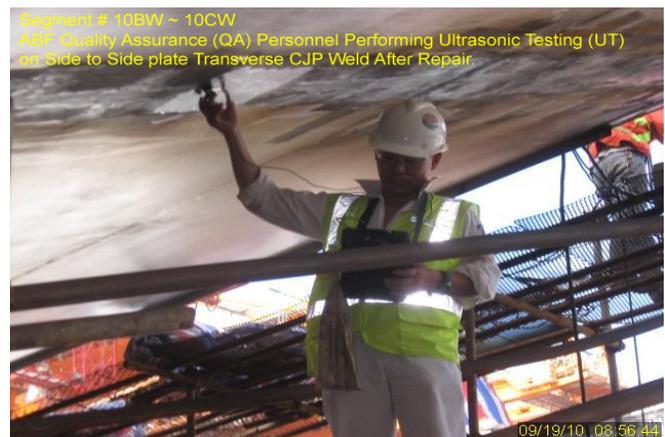
## Segment # 10BW ~ 10CW

During random visual inspection this Caltrans Quality Assurance (QA) inspector observed that American Bridge Fluor (ABF) Quality Assurance (QA) personnel had performed Ultrasonic Testing (UT) on Side to Side Plate Transverse CJP Weld in OBG segment 10BW ~ 10CW at panel point 91 to 92. See the attached Photo.
