Contract #: 04-0120F4Cty: SF/ALA Rte: 80 PM: 13.2/13.9File #: 1.28**WELDING INSPECTION REPORT****Resident Engineer:** Siegenthaler, Peter**Address:** 333 Burma Road**City:** Oakland, CA 94607**Report No:** WIR-016930**Date Inspected:** 24-Sep-2010**Project Name:** SAS Superstructure**OSM Arrival Time:** 1000**Prime Contractor:** American Bridge/Fluor Enterprises, a JV**OSM Departure Time:** 1830**Contractor:** American Bridge/Fluor Enterprises, a JV**Location:** Job Site**CWI Name:** See Below**CWI Present:** Yes No**Inspected CWI report:** Yes No N/A**Rod Oven in Use:** Yes No N/A**Electrode to specification:** Yes No N/A**Weld Procedures Followed:** Yes No N/A**Qualified Welders:** Yes No N/A**Verified Joint Fit-up:** Yes No N/A**Approved Drawings:** Yes No N/A**Approved WPS:** Yes No N/A**Delayed / Cancelled:** Yes No N/A**Bridge No:** 34-0006**Component:** Orthotropic Box Girders**Summary of Items Observed:**

A). Field Splice E6/E7

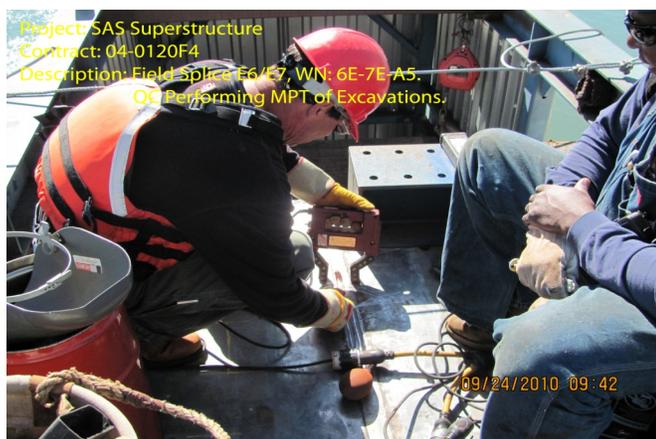
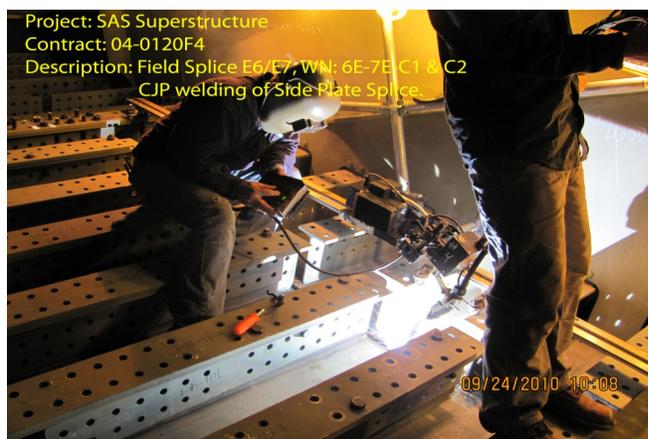
The QAI observed the excavations and the repair welding of the areas marked as UT rejects on the Complete Joint Penetration (CJP) groove weld identified as WN: 6E-7E-A5. The excavations and welding of the repairs was performed by the welder Fred Kaddu ID-2188 utilizing the Shielded Metal Arc Welding (SMAW) process and 4.0 mm electrode as per the Welding Procedure Specification (WPS) identified as ABF-WPS-1000 Repair Rev. 2. The WPS was also used by the QC inspector, Tom Pasqualone as a reference to monitor and verify the Direct Current welding parameters. The welder utilized a 3.2mm electrode for the application of the first weld layer and a 4.0mm for the fill and cover passes. The welding parameters were verified by the QC inspector and observed by the QAI as 124 amps for the 3.2mm electrode and 177 amps for the 4.0mm electrode. The welding was performed in the flat position (1G) with the work positioned placed in an approximately horizontal plane and the weld metal deposited from the upper side. The minimum preheat temperature of 40 degrees Celsius and the maximum interpass temperature of 230 degrees Celsius appeared to comply with the contract documents.

Later in the shift, the QAI observed the automatic Flux Cored Arc Welding (FCAW-G) of the weld joint identified as Weld Number (WN) 6E-7E-C1 and C2. The welding was performed by welding personnel welder /operators Rory Hogan ID-3186 and Jeremy Dolman ID-5042 utilizing the WPS ABF-D15-3042B-1 Rev. 0. The joint designation appeared to comply with AWS single-v-groove butt joint identified as B-U2a-G and the WPS was also used by the QC inspector John Pagliero as a reference to monitor and verify the Direct Current Electrode Positive (DCEP) welding parameters which was verified by the QC inspector and observed by the QAI as follows: 250 amps, 24.0 volts and a travel speed measured as 260 mm per minute. The welding was performed in vertical position (3G) at approximate incline of 22 degrees. The QC inspector also verified the minimum preheat temperature of 100 degrees Celsius and the maximum interpass temperature of 230 degrees Celsius. Later during the shift the QAI observed, at random intervals, the QC inspector monitoring the in process welding, the surface temperatures and verifying the DCEP welding parameters.

The digital photographs below illustrate the work observed during this scheduled shift.
