**DEPARTMENT OF TRANSPORTATION**

Contract #: 04-0120F4Cty: SF/ALA Rte: 80 PM: 13.2/13.9File #: 69.28**WELDING INSPECTION REPORT****Resident Engineer:** Siegenthaler, Peter**Address:** 333 Burma Road**City:** Oakland, CA 94607**Report No:** WIR-016940**Date Inspected:** 19-Sep-2010**Project Name:** SAS Superstructure**OSM Arrival Time:** 700**Prime Contractor:** American Bridge/Fluor Enterprises, a JV**OSM Departure Time:** 1900**Contractor:** Zhenhua Port Machinery Company, Ltd (ZPMC), Changxing Island **Location:** Shanghai, China**CWI Name:** Mr. Zhao Chen Sun**CWI Present:** Yes No**Inspected CWI report:** Yes No N/A**Rod Oven in Use:** Yes No N/A**Electrode to specification:** Yes No N/A**Weld Procedures Followed:** Yes No N/A**Qualified Welders:** Yes No N/A**Verified Joint Fit-up:** Yes No N/A**Approved Drawings:** Yes No N/A**Approved WPS:** Yes No N/A**Delayed / Cancelled:** Yes No N/A**Bridge No:** 34-0006**Component:** Tower**Summary of Items Observed:**

**Heavy Dock Jetty**

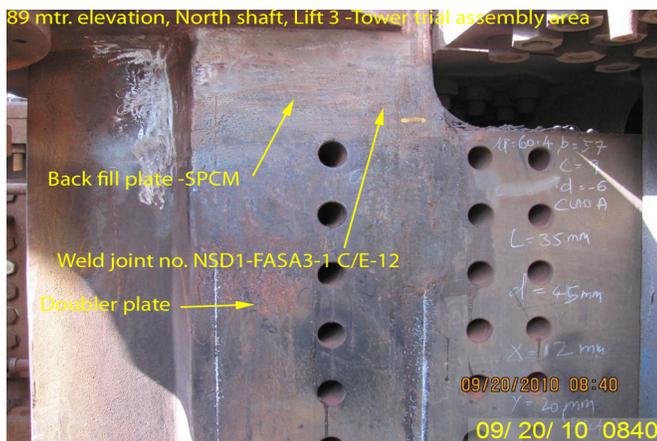
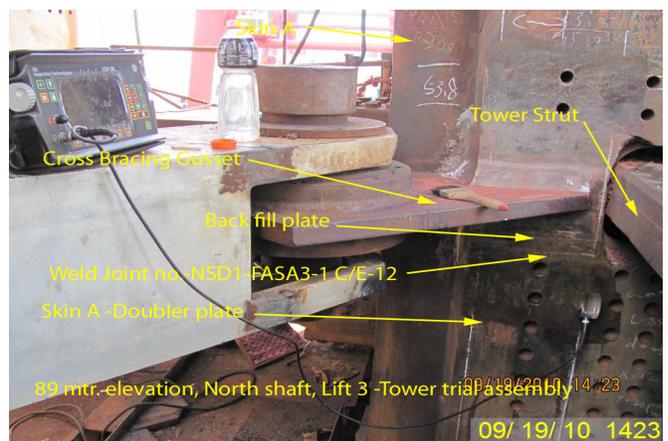
4. This QA inspector, Baskar Govindarajan, observed, during Ultrasonic Testing (UT) in 89mtr. elevation of North shaft, Lift 3 at Heavy Dock, Tower trial assembly area, Class A indication of approximately 35 mm in length . This was informed to ZPMC QC and ABF. Incident report wrote on this issue. (Photos attached)
