Contract #: 04-0120F4Cty: SF/ALA Rte: 80 PM: 13.2/13.9File #: 69.28**WELDING INSPECTION REPORT****Resident Engineer:** Siegenthaler, Peter**Address:** 333 Burma Road**City:** Oakland, CA 94607**Report No:** WIR-016973**Date Inspected:** 23-Sep-2010**Project Name:** SAS Superstructure**OSM Arrival Time:** 700**Prime Contractor:** American Bridge/Fluor Enterprises, a JV**OSM Departure Time:** 1900**Contractor:** Zhenhua Port Machinery Company, Ltd (ZPMC), Changxing Island **Location:** Shanghai, China**CWI Name:** Mr. Xu Le Fung.**CWI Present:** Yes No**Inspected CWI report:** Yes No N/A**Rod Oven in Use:** Yes No N/A**Electrode to specification:** Yes No N/A**Weld Procedures Followed:** Yes No N/A**Qualified Welders:** Yes No N/A**Verified Joint Fit-up:** Yes No N/A**Approved Drawings:** Yes No N/A**Approved WPS:** Yes No N/A**Delayed / Cancelled:** Yes No N/A**Bridge No:** 34-0006**Component:** Tower and Orthotropic Box Girder (OBG)**Summary of Items Observed:**

WELDING INSPECTION REPORT

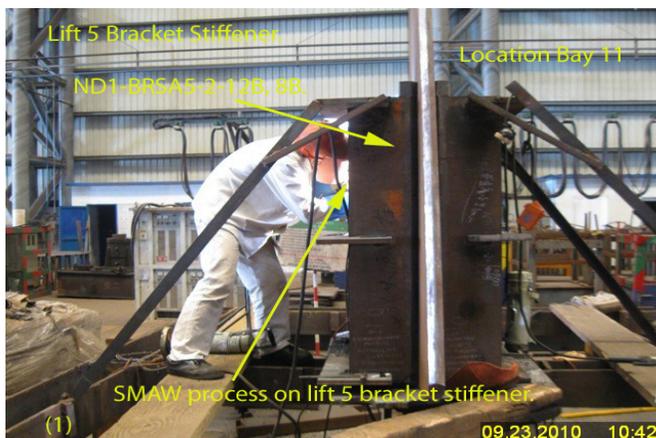
This QA Inspector observed ZPMC qualified welding personnel identified as 054460, 044541, Perform Shielded Metal Arc Welding (SMAW) on Lift 5 bracket stiffener. Joint identified as ND1-BRSA5-2-12B, 8B. ZPMC QC Identified as Liu Dao Feng. The welding parameters as measured using QC's calibrated instrument appeared to be in general compliance with WPS-B-T-3213-Tc-U4b. For more information see below attached picture number 1.

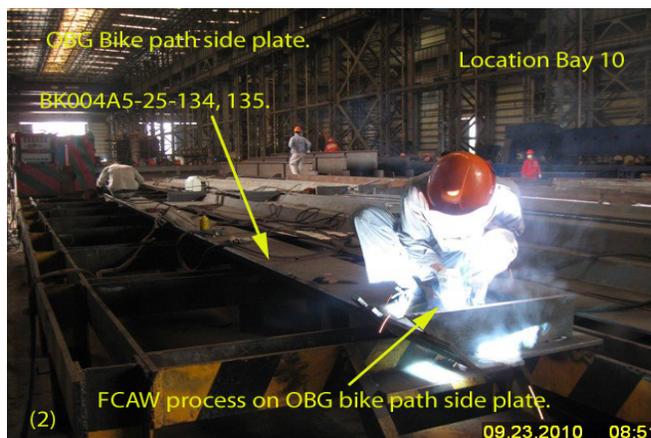
This QA Inspector observed ZPMC qualified welding personnel identified as 050289 Perform Shielded Metal Arc Welding (SMAW) on Bike path Plate. Joint identified as BK004A1-029-009. ZPMC QC Identified as Yuan Hai Gang with temporary welding repair report. The welding parameters as measured using QC's calibrated instrument appeared to be in general compliance with WPS-345-SMAW-1G (1F) Repair. For more information see below attached picture number 2.

This QA Inspector observed ZPMC qualified welding personnel identified as 040302, 057258, Perform Flux Core Arc Welding (FCAW) on OBG bike path side plate. Joint identified as BK004A5-25-134, 135. ZPMC QC Identified as Ma Qianli Ma. The welding parameters as measured using QC's calibrated instrument appeared to be in general compliance with WPS-B-T-2231-B-U2-F and WPS-B-T-2233-B-U2-F. For more information see below attached picture number 2.
