DEPARTMENT OF TRANSPORTATION

Quality Assurance and Source Inspection

Contract #: 04-0120F4Cty: SF/ALA Rte: 80 PM: 13.2/13.9File #: 69.28**WELDING INSPECTION REPORT****Resident Engineer:** Siegenthaler, Peter**Address:** 333 Burma Road**City:** Oakland, CA 94607**Report No:** WIR-016985**Date Inspected:** 26-Sep-2010**Project Name:** SAS Superstructure**OSM Arrival Time:** 700**Prime Contractor:** American Bridge/Fluor Enterprises, a JV**OSM Departure Time:** 1900**Contractor:** Zhenhua Port Machinery Company, Ltd (ZPMC), Changxing Island **Location:** Shanghai, China**CWI Name:** Li Yang**CWI Present:** Yes No**Inspected CWI report:** Yes No N/A**Rod Oven in Use:** Yes No N/A**Electrode to specification:** Yes No N/A**Weld Procedures Followed:** Yes No N/A**Qualified Welders:** Yes No N/A**Verified Joint Fit-up:** Yes No N/A**Approved Drawings:** Yes No N/A**Approved WPS:** Yes No N/A**Delayed / Cancelled:** Yes No N/A**Bridge No:** 34-0006**Component:** OBG Segment**Summary of Items Observed:**

WELDING INSPECTION REPORT

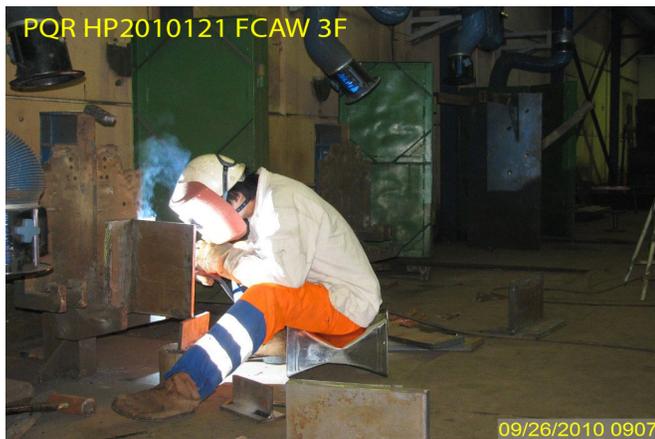
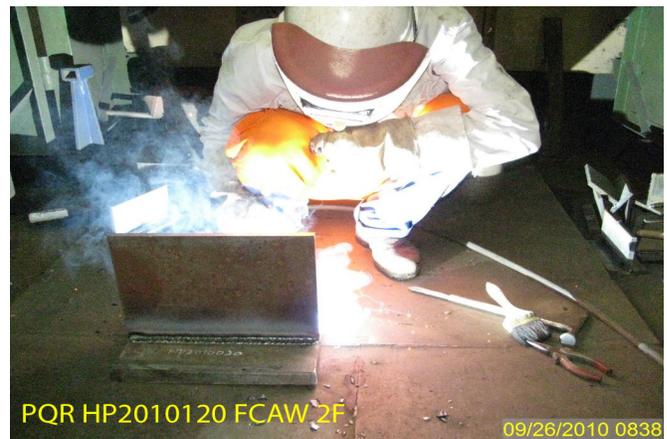
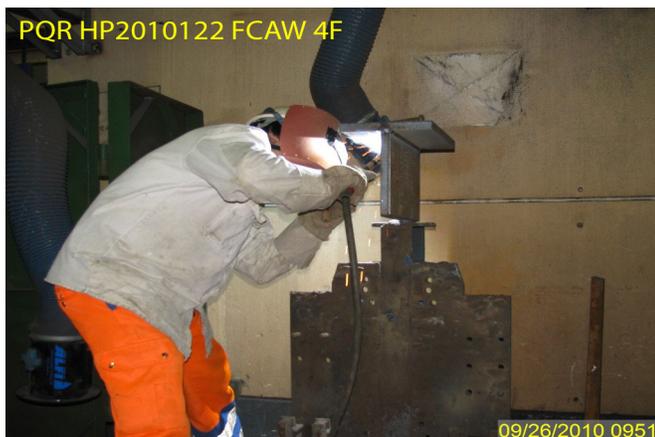
This QA Inspector observed the welding of 3 Procedure Qualification Records (PQR) using the Flux Cored Arc Welding (FCAW) process. The PQR was performed using ESAB E71T-M Dual Shield 70 Ultra Plus electrode. The electrode is 1.4mm in diameter, Lot # 89926. The test plate configuration was a Fillet weld T-Joint, T1 and T2 was 25mm in thickness and 350mm in length. The test plate material is identified as A709 GR345. The welder was identified as Liu Xie.

This QA Inspector observed Base Metal Repair using the Shielded Metal Arc Welding (SMAW) process at locations of removed fit up plates along the exterior of the Bottom Plate to Side Plate CJP hold back weld. The welder is identified as #202316 and was observed welding in the 4G (overhead) position using approved Welding Procedure Specification WPS-345-SMAW-4G (4F)-FCM-repair-1 for CWR1835.
