Contract #: 04-0120F4Cty: SF/ALA Rte: 80 PM: 13.2/13.9File #: 69.28**WELDING INSPECTION REPORT****Resident Engineer:** Siegenthaler, Peter**Address:** 333 Burma Road**City:** Oakland, CA 94607**Report No:** WIR-016988**Date Inspected:** 27-Sep-2010**Project Name:** SAS Superstructure**OSM Arrival Time:** 700**Prime Contractor:** American Bridge/Fluor Enterprises, a JV**OSM Departure Time:** 1900**Contractor:** Zhenhua Port Machinery Company, Ltd (ZPMC), Changxing Island **Location:** Shanghai, China**CWI Name:** Zhu Zhong Hai.**CWI Present:** Yes No**Inspected CWI report:** Yes No N/A**Rod Oven in Use:** Yes No N/A**Electrode to specification:** Yes No N/A**Weld Procedures Followed:** Yes No N/A**Qualified Welders:** Yes No N/A**Verified Joint Fit-up:** Yes No N/A**Approved Drawings:** Yes No N/A**Approved WPS:** Yes No N/A**Delayed / Cancelled:** Yes No N/A**Bridge No:** 34-0006**Component:** OBG components.**Summary of Items Observed:**

WELDING INSPECTION REPORT

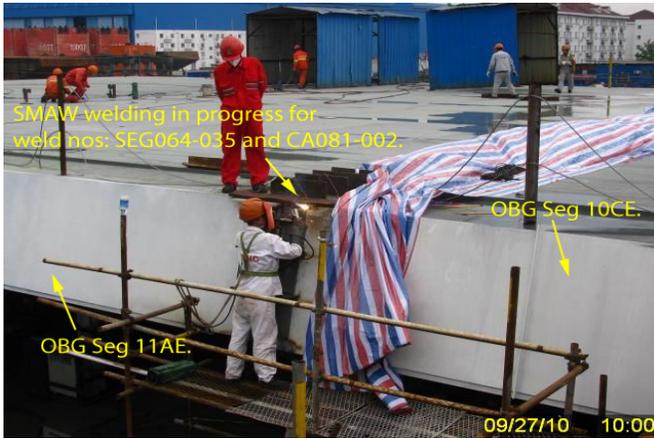
The SMAW process on weld joint no: SEG064-035. The welder is identified as 044504 and was observed welding in the 4G position. ZPMC QC was identified as Zhu Zhong Hai. The welding variables recorded by QC appeared to comply with WPS: B-P-2214-TC-U4b-FCM-1. See attached photo for further details.

The SMAW process on weld joint no: CA081-002. The welder is identified as 044504 and was observed welding in the 4G position. ZPMC QC was identified as Zhu Zhong Hai. The welding variables recorded by QC appeared to comply with WPS: B-P-2214-TC-U4b-FCM-1. See attached photo for further details.
