**DEPARTMENT OF TRANSPORTATION**

Contract #: 04-0120F4Cty: SF/ALA Rte: 80 PM: 13.2/13.9File #: 69.28**WELDING INSPECTION REPORT****Resident Engineer:** Siegenthaler, Peter**Address:** 333 Burma Road**City:** Oakland, CA 94607**Report No:** WIR-017010**Date Inspected:** 14-Sep-2010**Project Name:** SAS Superstructure**OSM Arrival Time:** 1900**Prime Contractor:** American Bridge/Fluor Enterprises, a JV**OSM Departure Time:** 700**Contractor:** Zhenhua Port Machinery Company, Ltd (ZPMC), Changxing Island **Location:** Shanghai, China**CWI Name:** See Below**CWI Present:** Yes No**Inspected CWI report:** Yes No N/A**Rod Oven in Use:** Yes No N/A**Electrode to specification:** Yes No N/A**Weld Procedures Followed:** Yes No N/A**Qualified Welders:** Yes No N/A**Verified Joint Fit-up:** Yes No N/A**Approved Drawings:** Yes No N/A**Approved WPS:** Yes No N/A**Delayed / Cancelled:** Yes No N/A**Bridge No:** 34-0006**Component:** OBG**Summary of Items Observed:**

**OBG Segment Trial Assembly**

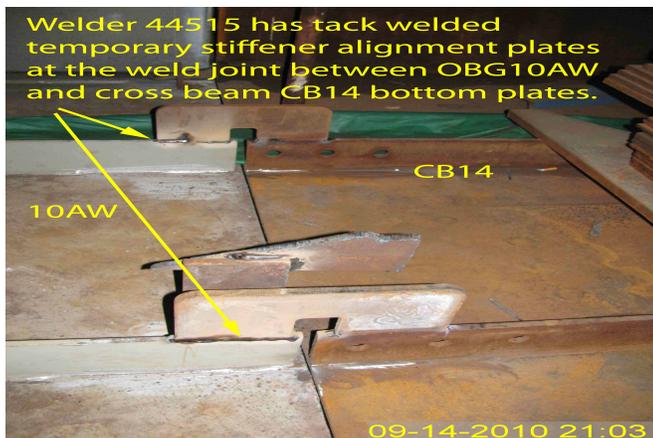
This QA Inspector observed ZPMC welder Mr. Xu Jian Wen, stencil 040378 recently used shielded metal arc welding process to weld temporary plates between OBG segment 10AW and cross beam 14 bottom plate stiffener plates. This QA Inspector observed Mr. Xu Jian Wen appeared to be certified to make these welds. Items observed on this date appeared to generally comply with applicable contract documents. See the photograph below for additional information.
