**DEPARTMENT OF TRANSPORTATION**

Contract #: 04-0120F4Cty: SF/ALA Rte: 80 PM: 13.2/13.9File #: 69.28**WELDING INSPECTION REPORT****Resident Engineer:** Siegenthaler, Peter**Address:** 333 Burma Road**City:** Oakland, CA 94607**Report No:** WIR-017013**Date Inspected:** 17-Sep-2010**Project Name:** SAS Superstructure**OSM Arrival Time:** 1900**Prime Contractor:** American Bridge/Fluor Enterprises, a JV**OSM Departure Time:** 700**Contractor:** Zhenhua Port Machinery Company, Ltd (ZPMC), Changxing Island **Location:** Shanghai, China**CWI Name:** See Below**CWI Present:** Yes No**Inspected CWI report:** Yes No N/A**Rod Oven in Use:** Yes No N/A**Electrode to specification:** Yes No N/A**Weld Procedures Followed:** Yes No N/A**Qualified Welders:** Yes No N/A**Verified Joint Fit-up:** Yes No N/A**Approved Drawings:** Yes No N/A**Approved WPS:** Yes No N/A**Delayed / Cancelled:** Yes No N/A**Bridge No:** 34-0006**Component:** OBG**Summary of Items Observed:**

**OBG Segment Trial Assembly**

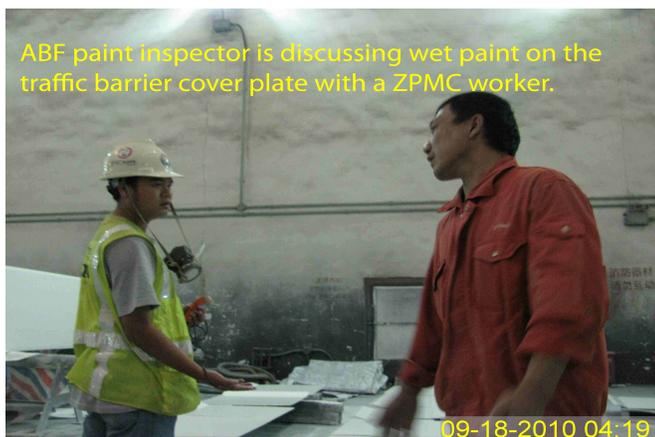
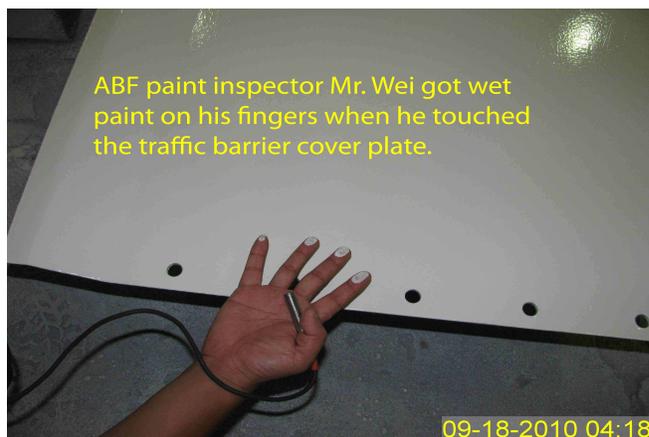
At around 0400 ABF Inspector Mr. Wei informed this QA Inspector that various final paint inspections are ready for DFT measurements. When this QA Inspector arrived in paint shop #2, Mr. Wei touched the top painted surface of one of the crash barrier cover plates and partially dried paint adhered to his fingertips. This indicates that the coating is not fully cured. This QA Inspector observed that the coating on the crash barriers was also not fully cured. ABF coating inspector Mr. Wei and Mr. Sun both indicated that these items will be allowed to cure prior to requesting another coating inspection. This QA Inspector observed Mr. Wei performing DFT measurements on request 4371 item #1 CB11 accessories 3 each and item #4 for the final DFT inspections. This QA Inspector observed CB11 accessories DFT readings appeared to comply with project specifications. Item # 2, crash barriers and item #3 crash barrier cover plates were both rejected by ABF due to uncured coatings. A QA lot number was written on this notification

Mr. Sun presented this QA Inspector with request T1203 and T1204 "Cross Beam #11 Channel", 5 each. Request T2103 was a notification of final finish coat application and request T2104 was for final DFT inspection. Mr. Sun indicated that request T1204 had been delayed due to uncured coatings.
