Contract #: 04-0120F4Cty: SF/ALA Rte: 80 PM: 13.2/13.9File #: 69.28**WELDING INSPECTION REPORT****Resident Engineer:** Siegenthaler, Peter**Address:** 333 Burma Road**City:** Oakland, CA 94607**Report No:** WIR-017015**Date Inspected:** 19-Sep-2010**Project Name:** SAS Superstructure**OSM Arrival Time:** 1900**Prime Contractor:** American Bridge/Fluor Enterprises, a JV**OSM Departure Time:** 700**Contractor:** Zhenhua Port Machinery Company, Ltd (ZPMC), Changxing Island **Location:** Shanghai, China**CWI Name:** See Below**CWI Present:** Yes No**Inspected CWI report:** Yes No N/A**Rod Oven in Use:** Yes No N/A**Electrode to specification:** Yes No N/A**Weld Procedures Followed:** Yes No N/A**Qualified Welders:** Yes No N/A**Verified Joint Fit-up:** Yes No N/A**Approved Drawings:** Yes No N/A**Approved WPS:** Yes No N/A**Delayed / Cancelled:** Yes No N/A**Bridge No:** 34-0006**Component:** OBG**Summary of Items Observed:**

OBG Segment Trial Assembly

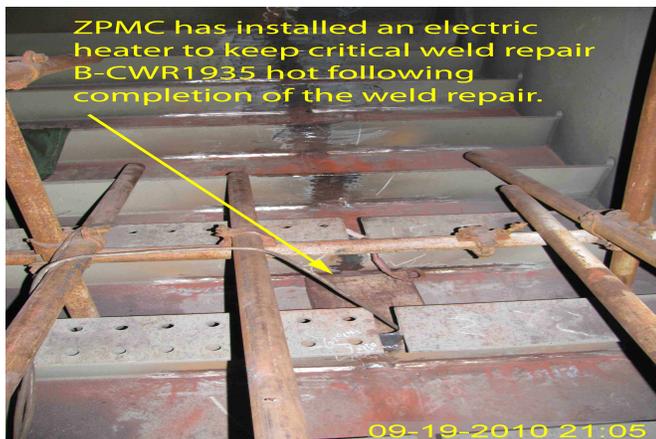
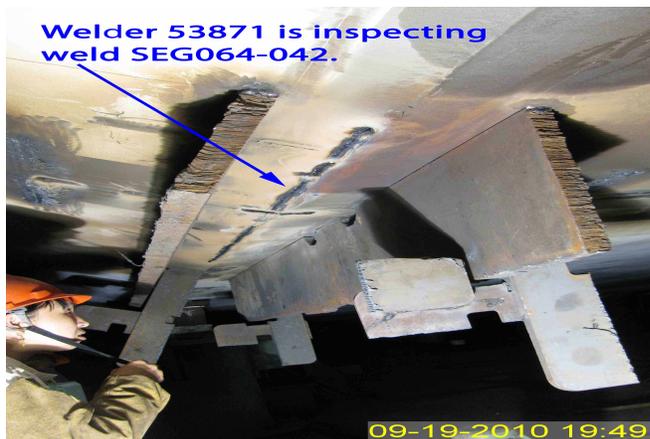
This QA Inspector observed ZPMC workers were performing heat straightening of OBG longitudinal diaphragm LD013-001 that had been distorted during welding of welds 001 through -012. ZPMC has issued heat straightening document HSR1(B)9053 to complete his work. Items observed on this date appeared to generally comply with applicable contract documents.
