Contract #: 04-0120F4Cty: SF/ALA Rte: 80 PM: 13.2/13.9File #: 69.28**WELDING INSPECTION REPORT****Resident Engineer:** Siegenthaler, Peter**Address:** 333 Burma Road**City:** Oakland, CA 94607**Report No:** WIR-017030**Date Inspected:** 26-Sep-2010**Project Name:** SAS Superstructure**OSM Arrival Time:** 1900**Prime Contractor:** American Bridge/Fluor Enterprises, a JV**OSM Departure Time:** 700**Contractor:** Zhenhua Port Machinery Company, Ltd (ZPMC), Changxing Island **Location:** Shanghai, China**CWI Name:** See Below**CWI Present:** Yes No**Inspected CWI report:** Yes No N/A**Rod Oven in Use:** Yes No N/A**Electrode to specification:** Yes No N/A**Weld Procedures Followed:** Yes No N/A**Qualified Welders:** Yes No N/A**Verified Joint Fit-up:** Yes No N/A**Approved Drawings:** Yes No N/A**Approved WPS:** Yes No N/A**Delayed / Cancelled:** Yes No N/A**Bridge No:** 34-0006**Component:** OBG**Summary of Items Observed:**

OBG Segment Trial Assembly

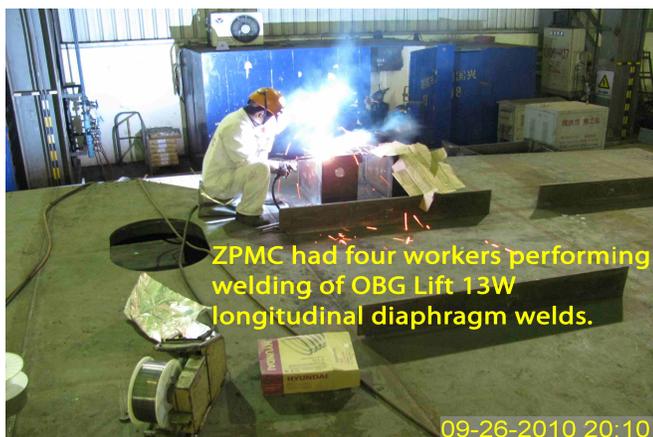
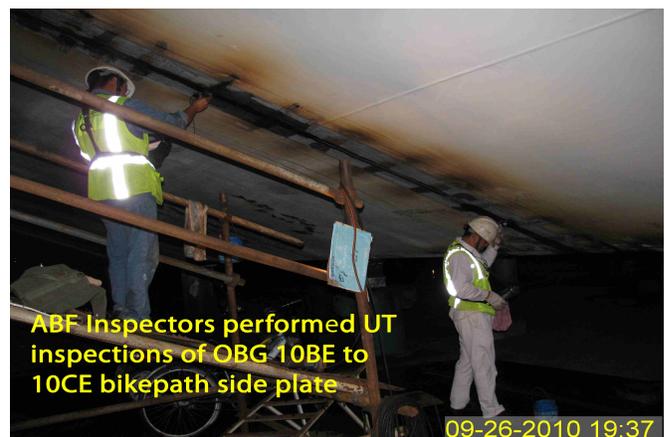
This QA Inspector observed ZPMC welder Mr. Zhang Heishan, stencil 040458 used flux cored welding procedure WPS-B-T-2132 to make to make bikepath weld BK004A6-013-041. This QA Inspector observed a welding current of approximately 300 amps, 33.0 volts and Mr. Zhang Heishan appeared to be certified to make this weld. Items observed on this date appeared to generally comply with applicable contract documents.
