**DEPARTMENT OF TRANSPORTATION**

Contract #: 04-0120F4Cty: SF/ALA Rte: 80 PM: 13.2/13.9File #: 69.28**WELDING INSPECTION REPORT****Resident Engineer:** Siegenthaler, Peter**Address:** 333 Burma Road**City:** Oakland, CA 94607**Report No:** WIR-017048**Date Inspected:** 16-Sep-2010**Project Name:** SAS Superstructure**OSM Arrival Time:** 1500**Prime Contractor:** American Bridge/Fluor Enterprises, a JV**OSM Departure Time:** 300**Contractor:** Zhenhua Port Machinery Company, Ltd (ZPMC), Changxing Island **Location:** Shanghai, China**CWI Name:** Wang Jie, Geng Wei**CWI Present:** Yes No**Inspected CWI report:** Yes No N/A**Rod Oven in Use:** Yes No N/A**Electrode to specification:** Yes No N/A**Weld Procedures Followed:** Yes No N/A**Qualified Welders:** Yes No N/A**Verified Joint Fit-up:** Yes No N/A**Approved Drawings:** Yes No N/A**Approved WPS:** Yes No N/A**Delayed / Cancelled:** Yes No N/A**Bridge No:** 34-0006**Component:** OBG**Summary of Items Observed:**

## WELDING INSPECTION REPORT

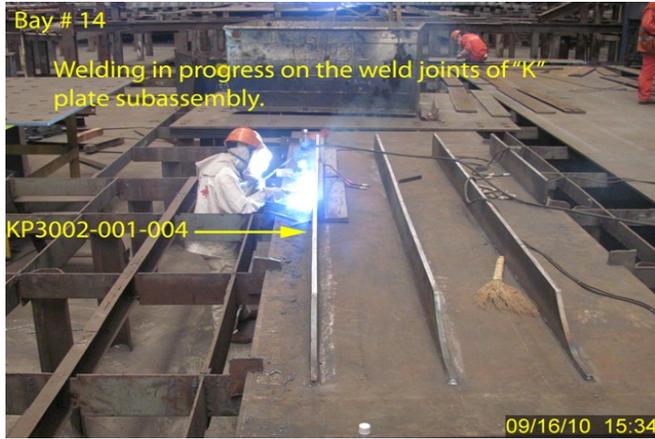
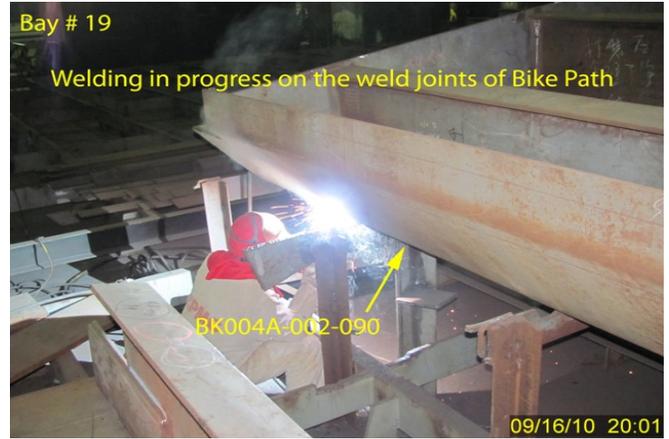
During random in process inspection this QA inspector observed that ZPMC personnel performing fit up by using Flux Cored Arc Welding (FCAW) process for deck plate SEG3014-007(DP3131A+DP3132A). Welder is identified as 202122. ZPMC QC is identified as Mr. Xia Chun Hui. The welding variables recorded by QC appeared to comply with WPS-B-P-2231-B-U2-F.

During random in process inspection this QA inspector observed that ZPMC personnel performing heat straightening on the weld joints of bottom plate of 13AW. The members are identified as OBG components and the weld designations reviewed are as follows.
